# COMANCHE GEAR

## NOSE GEAR DOORS ACTUATOR BRACKET ASSEMBLY REFURBISH

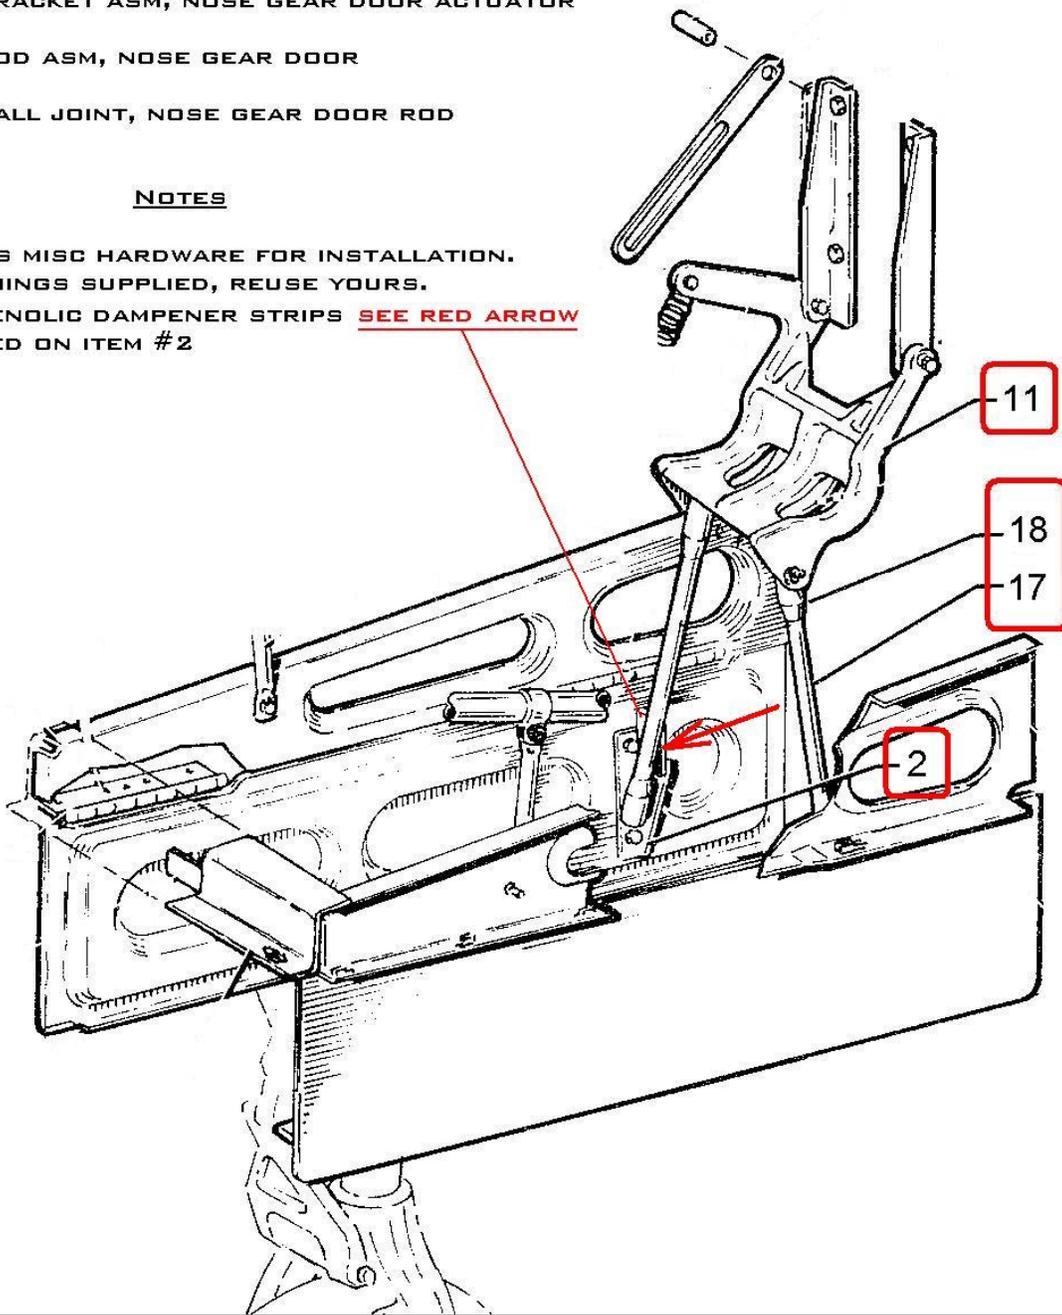
- # 2 BRACKET ASM, NOSE GEAR DOOR
- #11 BRACKET ASM, NOSE GEAR DOOR ACTUATOR
- #17 ROD ASM, NOSE GEAR DOOR
- #18 BALL JOINT, NOSE GEAR DOOR ROD

INCLUDES MISC HARDWARE FOR INSTALLATION.  
NO BUSHINGS SUPPLIED, REUSE YOURS.  
NEW PHENOLIC DAMPENER STRIPS SEE RED ARROW  
INSTALLED ON ITEM #2

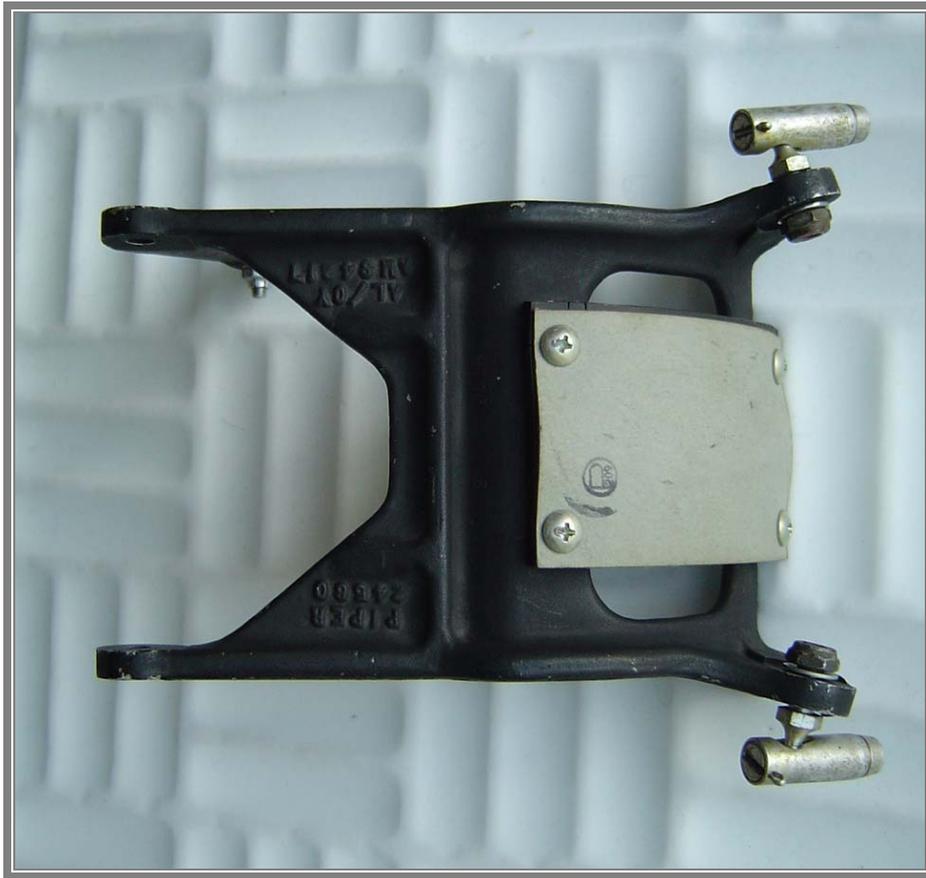
2) THE NOSE GEAR DOOR ACTUATOR BRACKET ASSEMBLY, #11 BELOW, ORIGINALLY HAD A RUBBER PLATE AND RUB STRIP ATTACHED WHICH CONTACTS THE STRUT TUBE AS THE GEAR IS RETRACTED – SEE THE PHOTO OF THE ORIGINAL ON PAGE 3. THE GEAR RETRACTING ACTION CAUSES THE #11 ACTUATOR TO PIVOT, PULLING ON THE RODS WHICH ARE ATTACHED TO THE DOOR BRACKETS, AND THE DOORS ARE THUSLY PULLED CLOSED. IF THIS BRACKET ASSEMBLY IS DIMENSIONALLY COMPROMISED, GAINING COMPLETE DOOR CLOSURE WITH PRELOAD AS SPECIFIED IN THE SERVICE MANUAL CAN BE IMPOSSIBLE. AN ENGINE OIL LEAK OR OIL CHANGES DRIPPING ONTO THE RUBBER SHOE WILL DETERIORATE THE RUBBER; LIKEWISE AGE AND ELEVATED TEMPERATURE. BOTH OF THESE CONDITIONS ARE CONTRIBUTING FACTORS.

**NEW OLD STOCK ACTUATOR BRACKET ASSEMBLY.**

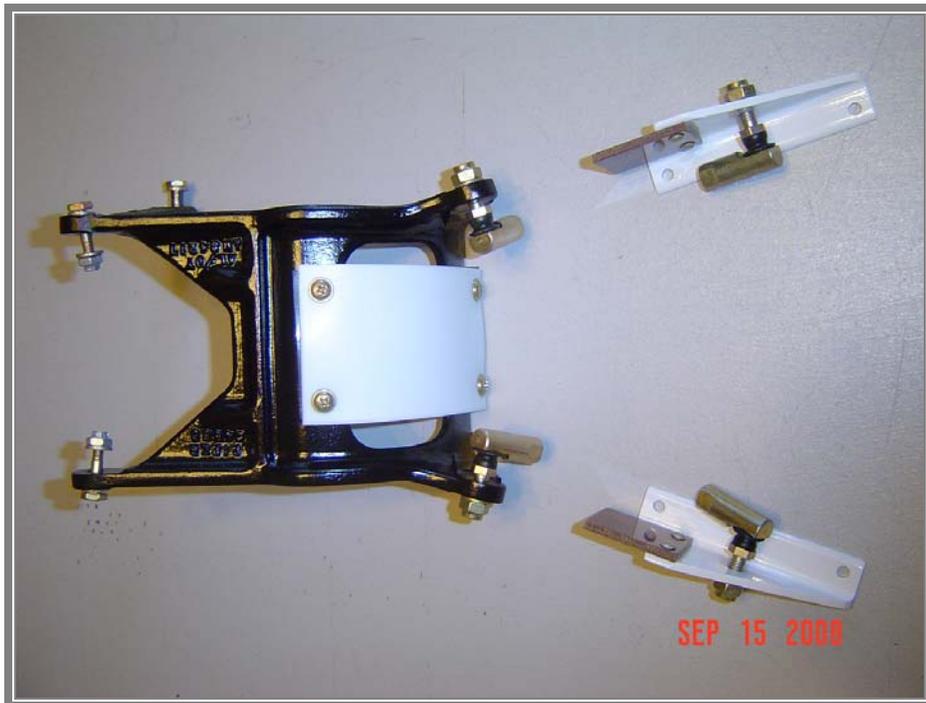
**BRACKET ASSEMBLIES REFURBISHED; CADMIUM PLATED RODS AND COMPLETE HARDWARE COMPLIMENT NOT SHOWN.**

THE [SERVICEABLE] ALUMINUM CASTING IS PAINT STRIPPED, GLASS BEAD BLASTED, CLEANED AND ALODINE® TREATED BEFORE APPLICATION OF ZINC CHROMATE PRIMER AND BLACK EPOXY FINISH. A NEW 70A DUROMETER HARD RUBBER “SHOE” IS THEN FITTED, FOLLOWED BY A TEFLON® RUB STRIP INSTEAD OF THE ORIGINAL MATERIAL. NEW HARDWARE IS USED THROUGHOUT.

THE NEXT DETAIL IS TO SIMILARLY TREAT THE #2 DOOR BRACKETS; THEY ARE REFINISHED IN GLOSSY WHITE. NEW PHENOLIC DAMPENER STRIPS ARE RIVETED TO THESE BRACKETS AFTER PAINTING. THESE DAMPENER STRIPS ARE SUPPOSED TO CONTACT THE RODS WHEN THE DOORS ARE FULLY OPEN.

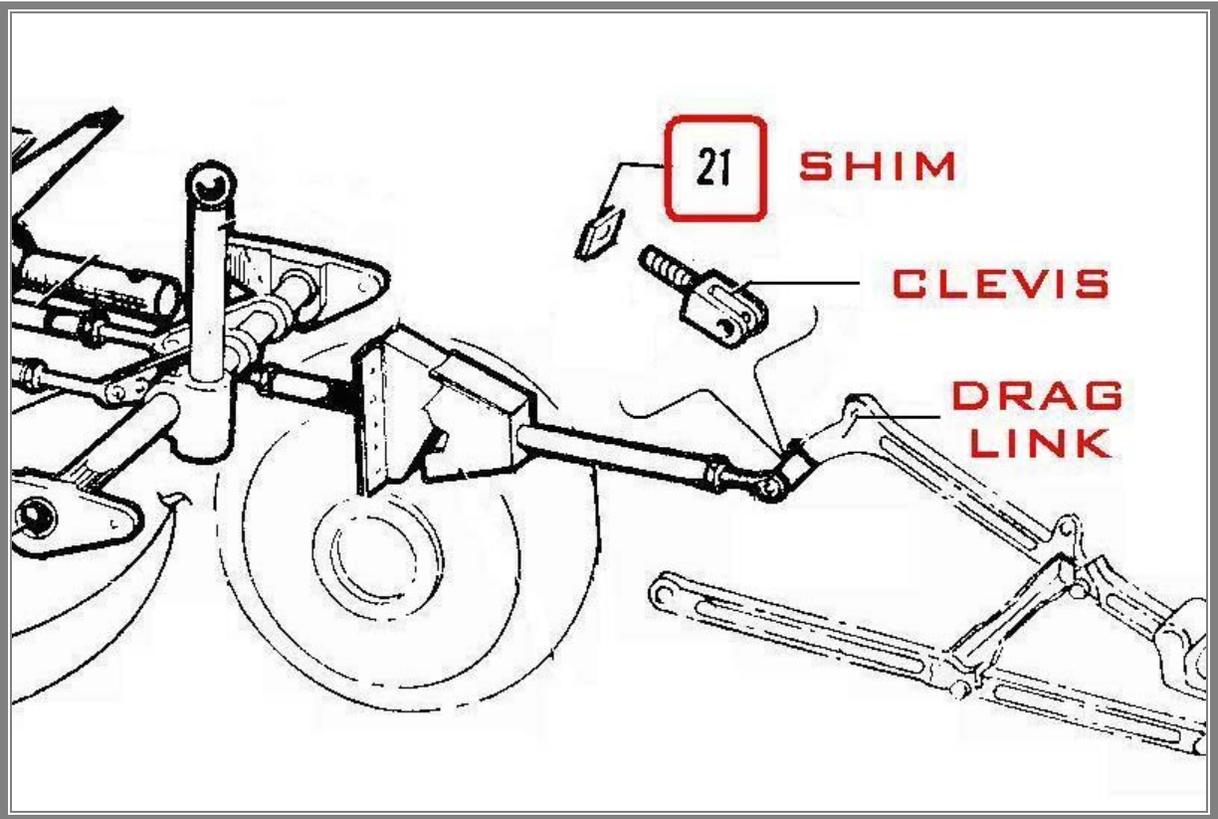
FIGURE 17, ITEM# 21

NOTES: ONLY STRAIGHT AND ORIGINAL LENGTH RODS 6.75 INCHES ARE ACCEPTABLE FOR EXCHANGE. THE #2 BRACKETS YOU RETURN MUST NOT HAVE ADDITIONAL HOLES DRILLED IN AN ATTEMPT TO SOLVE THIS PROBLEM DESCRIBED ABOVE; \$20 EACH BRACKET; \$10 EACH ROD IF THEY ARE NOT ACCEPTABLE. KEEP THE OLD BALL JOINTS AND HARDWARE. YOU’LL NEED TO REUSE THE 2 BUSHINGS LOCATED AT THE AN3 BOLT PIVOTS – SEE THE PHOTO ON THE BOTTOM OF PAGE 3.
