SERVICE LETTER

No. 679

Piper Aircraft Corporation

Fuselage Aft Bulkhead Inspection

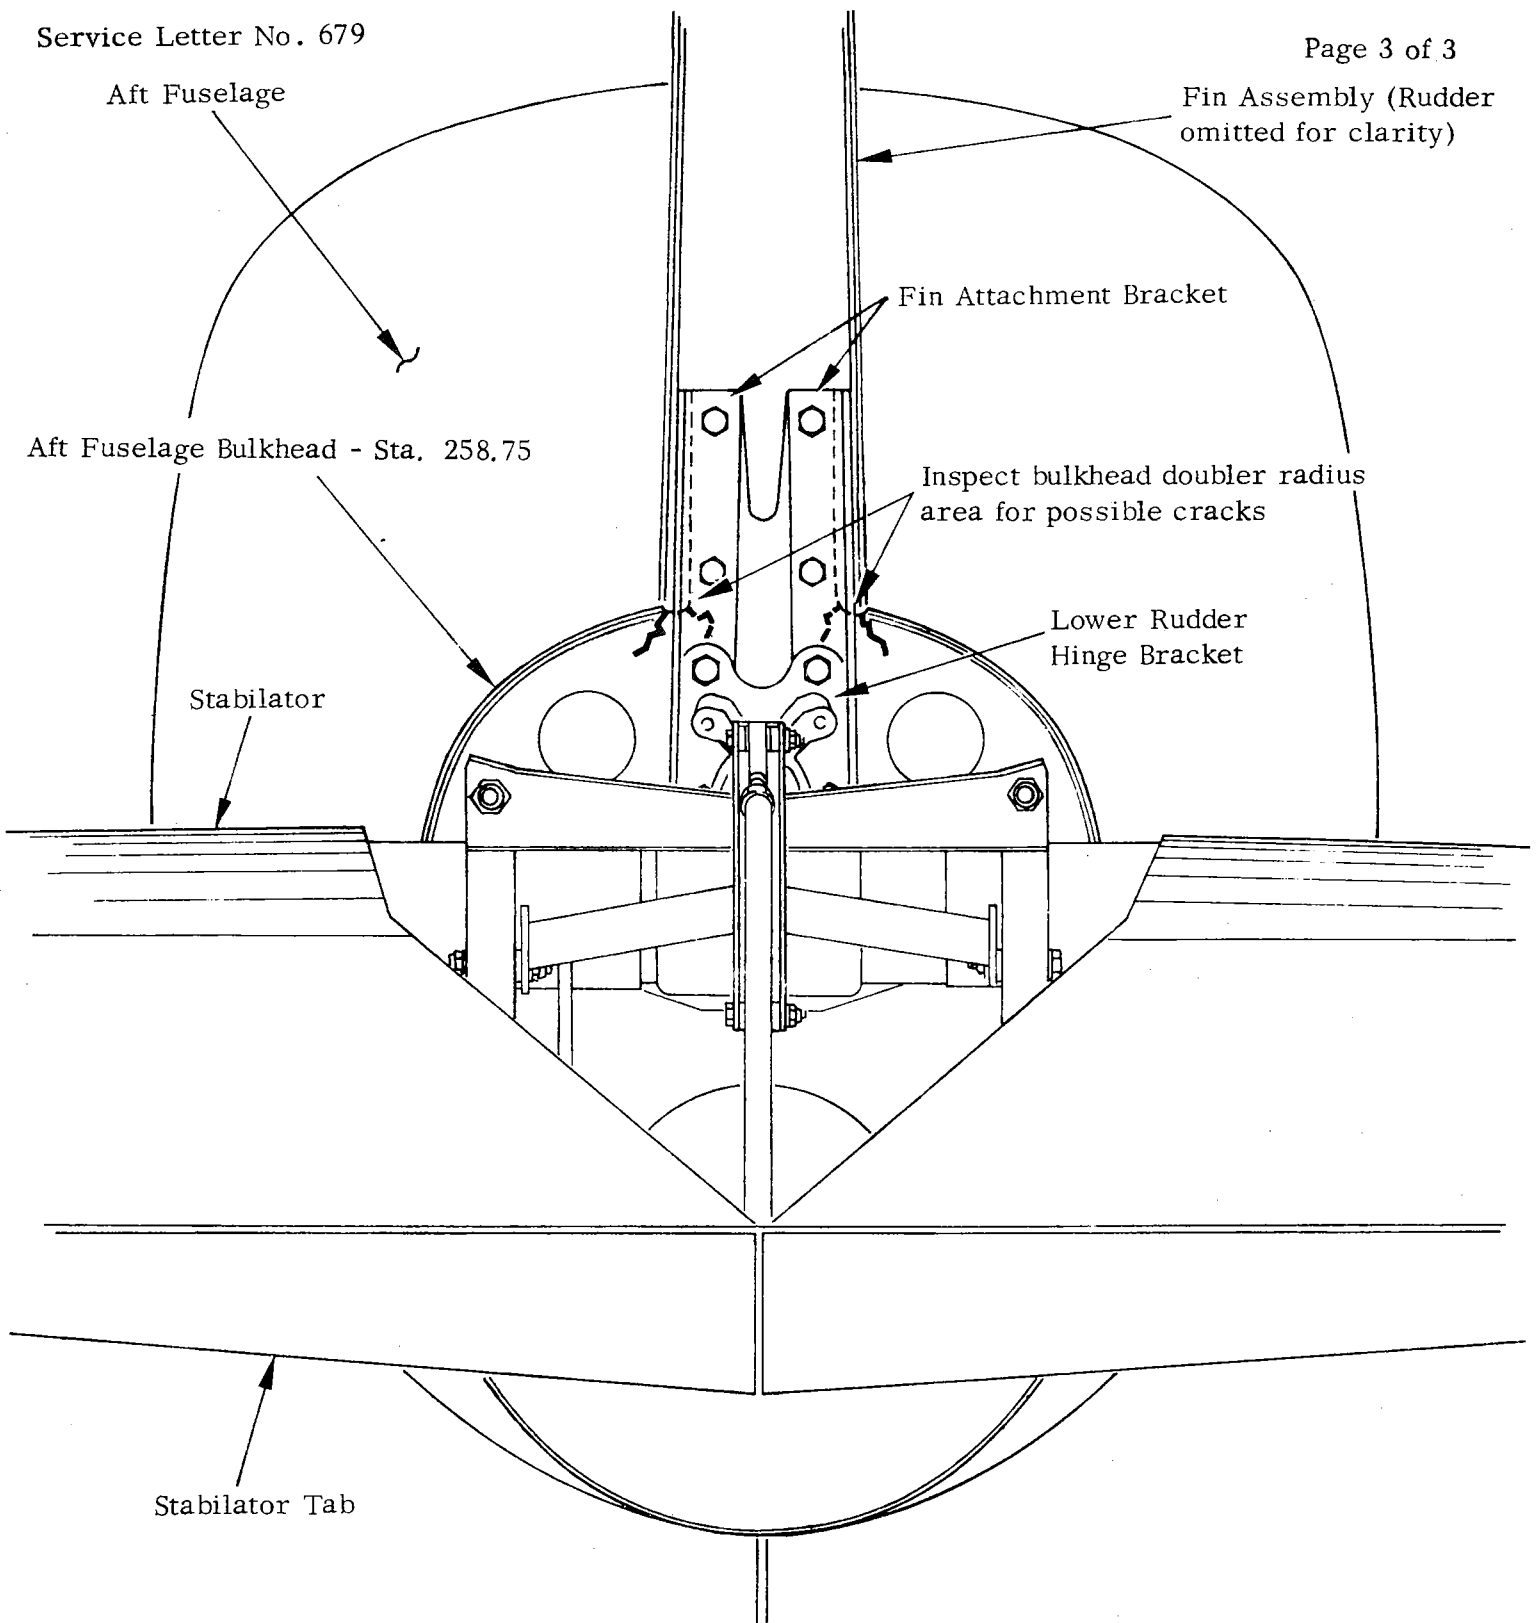
TYPICAL VIEW OF AFT FUSELAGE (LOOKING FORWARD)

To provide instructions to inspect the fuselage aft bulkhead doubler at fuselage station 258.75 in the area of the aft fin attachment brackets for evidence of cracks and to provide material and instructions to reinforce this area (1) if cracks are detected or (2) to alleviate the repetitive inspection requirements as stated in Compliance Time, above.

1. Remove tail cone fairing assembly from aft fuselage.
2. Carefully inspect bulkhead doubler on both sides of fin attachment brackets, as shown above, for evidence of cracks.
3. If cracks are detected, it will necessary to install the Fin Attachment Bracket Installation Kit P/N 760 783.
4. If cracks are not present, no further action is required at this time. (See Compliance Time.)
5. Reinstall tail cone fairing assembly.

3. If cracks are detected in this area, it will be necessary to install the Fin Attachment Bracket Installation Kit, Piper Part No. 760 783; installation instructions are contained in the kit.
4. Make appropriate log book entry.
