# COMANCHE GEAR

## MAIN LANDING GEAR STRUT HOUSING CRACKS

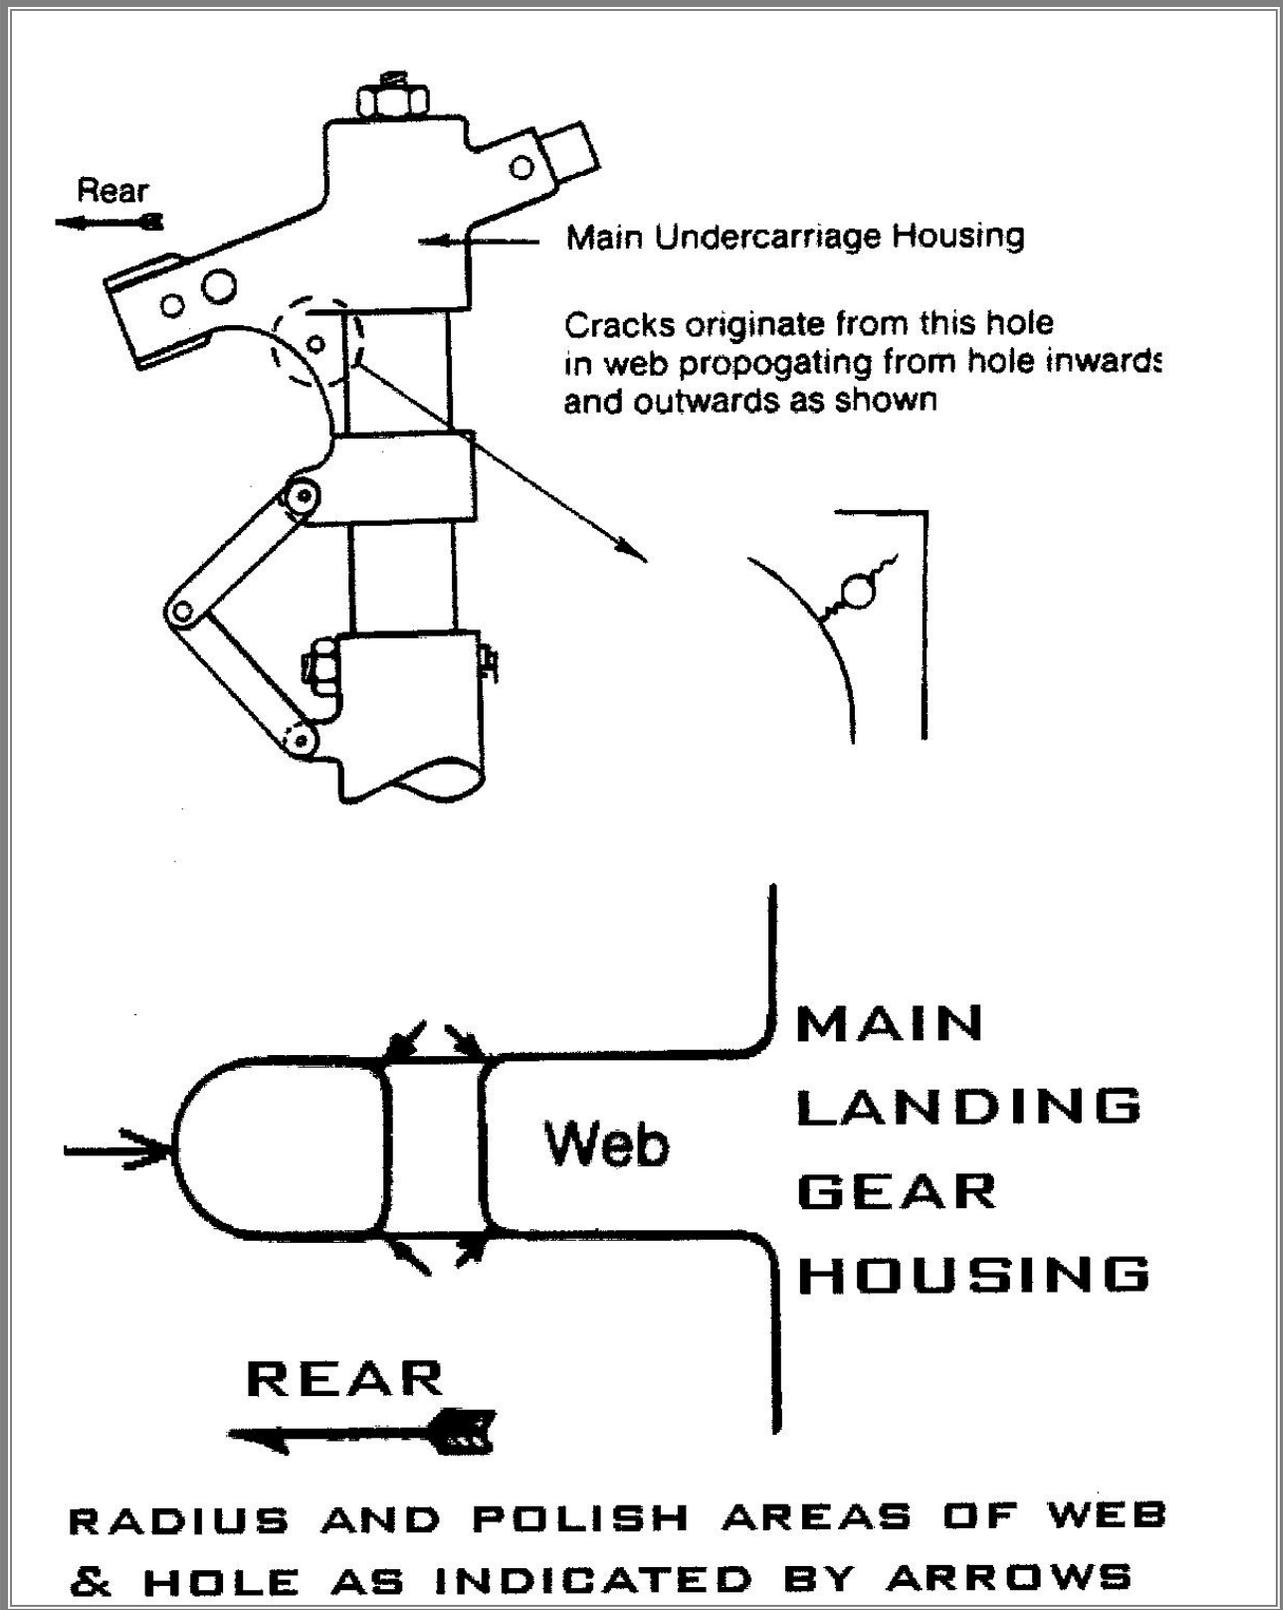
THE ABOVE SKETCH IS FROM THE ICS TIPS.  
 CAN YOU FIND THE MISTAKE; IT'S THE BOLT ORIENTATION?

LIGHTLY CHAMFER BOTH SIDES OF THE 3/16" HOLE WITH A 45° TOOL WHICH IS USED SPECIFICALLY FOR THIS PURPOSE, NO CHATTERING; THEN POLISH THE EDGES OF THE 3/16 HOLE WITH AN ABRASIVE IMPREGNATED POLISHING TOOL IN A DREMEL-TYPE TOOL. FOR THE WEB AREA NEAR THE HOLE USE A 120 GRIT 3" DIAMETER SANDING DRUM [FLAPPER-TYPE SANDING WHEEL IS OK TOO] AND FINISH ON A 7" SCOTCH-BRITE® WHEEL; PORTABLE EQUIPMENT AND A SMALLER SCOTCH-BRITE® WHEEL IS LIKewise ACCEPTABLE. THE TOOLING I REFERENCE IS AVAILABLE AT MCMaster-CARR, OR SEND THE HOUSINGS TO ME; IT'S EASY WHEN YOU HAVE THE RIGHT STUFF TO DO IT. AFTER YOU'VE FINISHED THE ABOVE, REDO THE ALODINE® CONVERSION COATING, THAT'S THE GOLD-COLORED TREATMENT SEEN ON THE ORIGINALS AND THE PHOTOS BELOW. THE REASON FOR THE ALODINE® IS CORROSION PREVENTION AND PAINT ADHESION. THE STEEL CLAMP YOU REMOVED TO GAIN ACCESS SHOULD ALSO BE TREATED PROPERLY; DON'T REINSTALL A RUSTY COMPONENT BACK ONTO THE STRUT HOUSING WITH THE OLD NASTY HARDWARE AND MERRILY GO YOUR WAY. YOU NEED TO THINK REALLY LONG TERM WHEN DOING THIS. I PREFER TO HAVE THE STEEL COMPONENTS CADMIUM PLATED; I KNOW THAT SOUNDS LIKE A PAIN; MOST PROPELLER SHOPS SHOULD HAVE THAT CAPABILITY. PLAN AHEAD AND DO IT. INSTALL THE COMPONENTS WITH NEW HARDWARE. IF YOU HAVE CORROSION UNDER THE CLAMP OR ELSEWHERE ON THE HOUSING, IT SHOULD BE REMOVED. DISASSEMBLE THE STRUT, USE PAINT REMOVER [IF POSSIBLE SAVE THE ADVISEMENT PLACARDS], AND THEN GLASS BEAD BLAST TO REMOVE THE CORROSION. AGAIN I KNOW THIS SOUNDS LIKE A PAIN; IT'S THE PROPER PROCEDURE. REFINISH WITH EPOXY ZINC CHROMATE OR OTHER EPOXY PRIMER [PAINT WON'T ADHERE WELL WITHOUT THE ALODINE® SO DON'T TRY IT WITHOUT - YOU'LL BE SORRY! THEN APPLY YOUR CHOICE OF TOP COAT COLOR. PLEASE DON'T USE AEROSOL CANS; I FEAR THE LONGEVITY JUST ISN'T IN THAT METHOD. IF YOU'VE DECIDED TO GO THIS ROUTE, THEN PLAN FOR CATALYZED FINISHES TOO. NOW YOU HAVE A STRUT HOUSING THAT YOU WON'T HAVE TO WORRY ABOUT, LOOKS GOOD AGAIN, AND YOU CAN BE THE ENVY OF THE NEXT HANGAR BS SESSION.

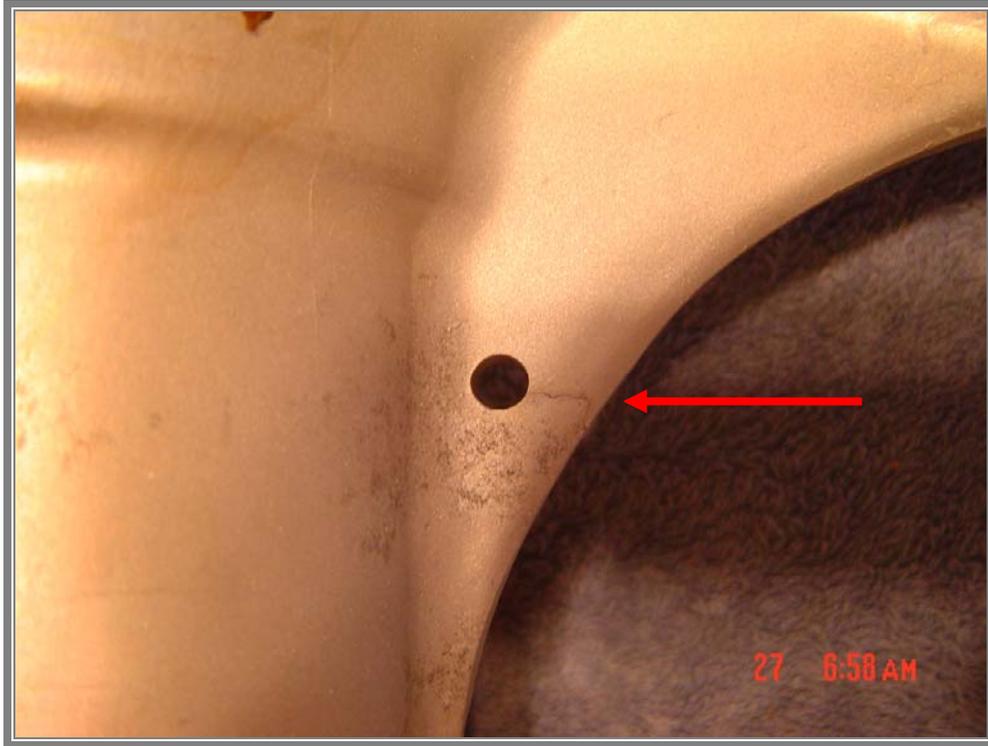
THE CRACK ADDRESSED HERE IS FROM THE 3/16" HOLE TO THE EDGE OF THE WEB, SEE PAGE 3. THAT CRACK CAN EVENTUALLY PROPAGATE TO THE HOUSING OLEO SECTION AND WHICH WILL LEAD TO THE LOSS OF HYDRAULIC FLUID AND SUBSEQUENT OLEO COLLAPSE. AND GUESS WHAT? IF THAT DOESN'T HAPPEN IN YOUR HANGAR YOU ARE STRANDED, NOT GOOD; READ ON.

**SO WHAT CAUSES THE CRACK?** THE REDUCED DIAMETER SECTION OF THE STRUT HOUSING IS WEAKER THAN THE LARGER DIAMETER SECTION. A SIDE LOAD WILL BEND THE STRUT SLIGHTLY AND THIS IS THE SECTION WHERE THE BENDING OCCURS. THE STRESS RISER IS THE UN-CHAMFERED 3/16" HOLE. TRY AVOIDING FAST TURNS AND NO SHARP TURNS AT ANY SPEED ABOVE CREEP WILL HELP PREVENT THIS CRACKING ISSUE. BRAKE APPLICATION IN A TURN WILL AGGRAVATE THIS.

**TO POTENTIALLY AVOID THE COSTLY REPAIR LIKE THIS CRACKED HOUSING WILL REQUIRE, SEE THE PREVIOUS PAGES AND THE PHOTO ON PAGE 4. NOTICE THE 3/16" HOLE'S SHARP EDGE; SEE THE CHAMFERED & POLISHED HOLE ON PAGE 4.**

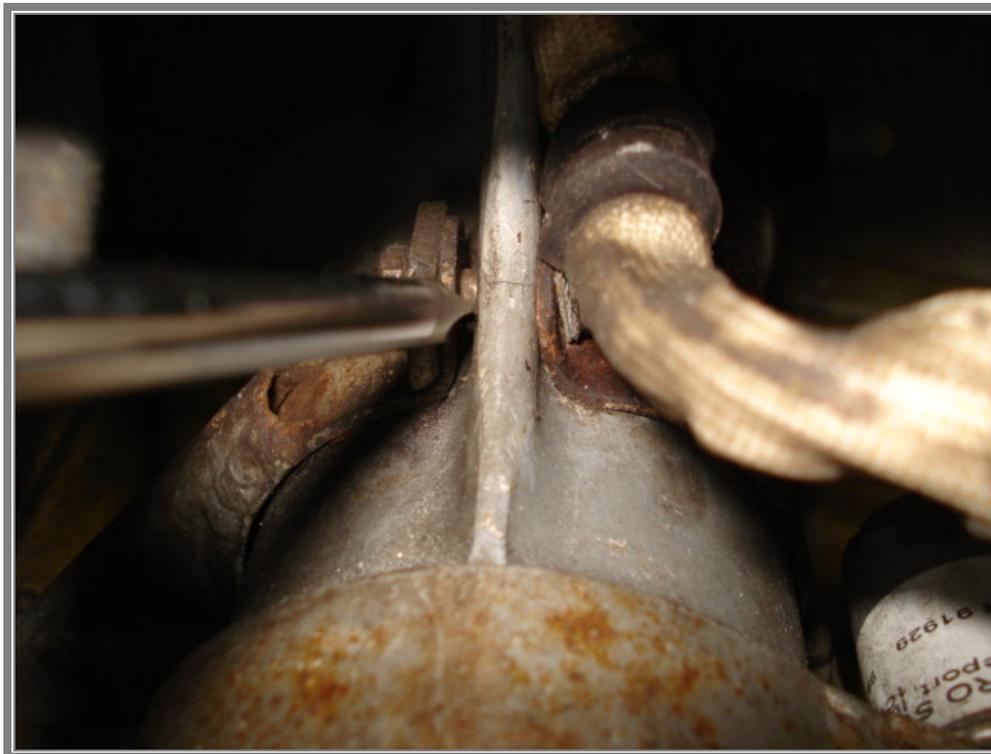
**THE SCREWDRIVER POINTING INDICATES WHERE TO LOOK FOR THE CRACK; AT THE BACKSIDE OF THE WEB.**

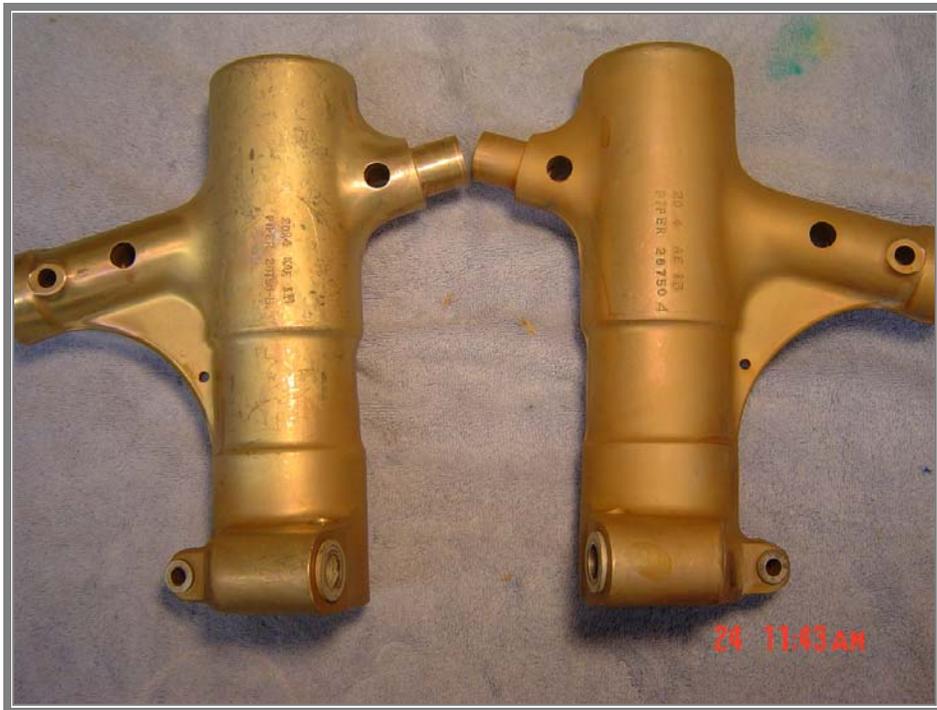
**THESE HOUSINGS HAVE BEEN POLISHED AND CHAMFERED, GLASS BEAD BLASTED, AND ALODINE® TREATED; READY FOR PRIMER.**

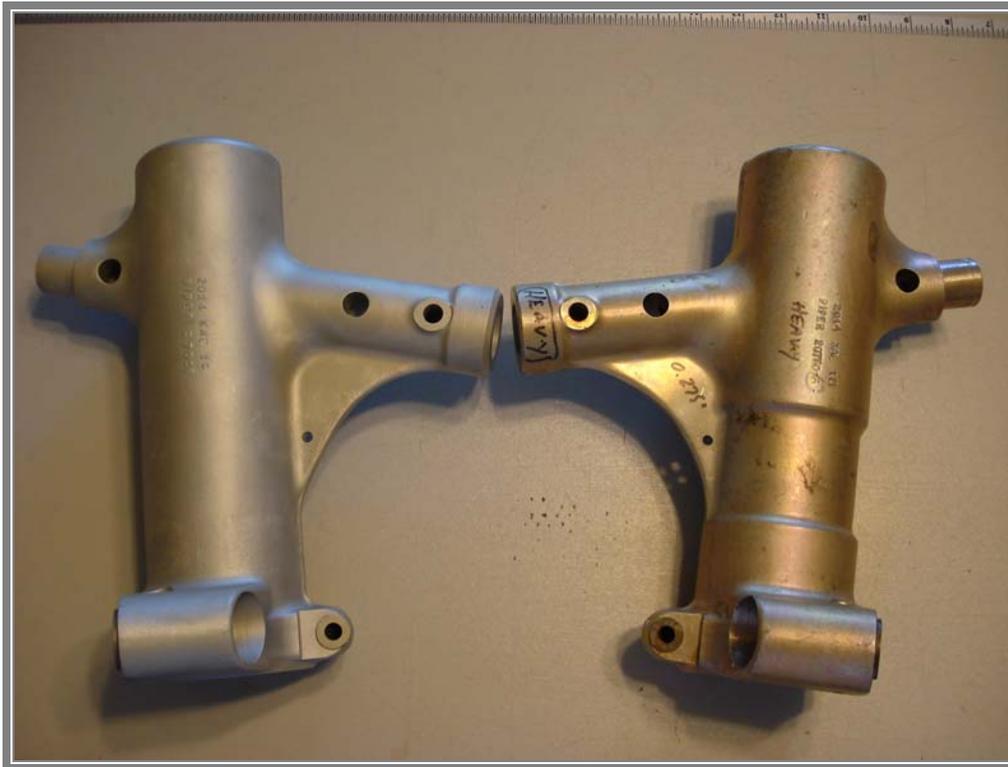
**PIPER'S IMPROVED-VERSION STRUT HOUSING SHOWN ON THE LEFT. NOTICE THE STRAIGHT SECTION; NO REDUCED-DIAMETER SECTION AS THE ORIGINAL ON THE RIGHT.**

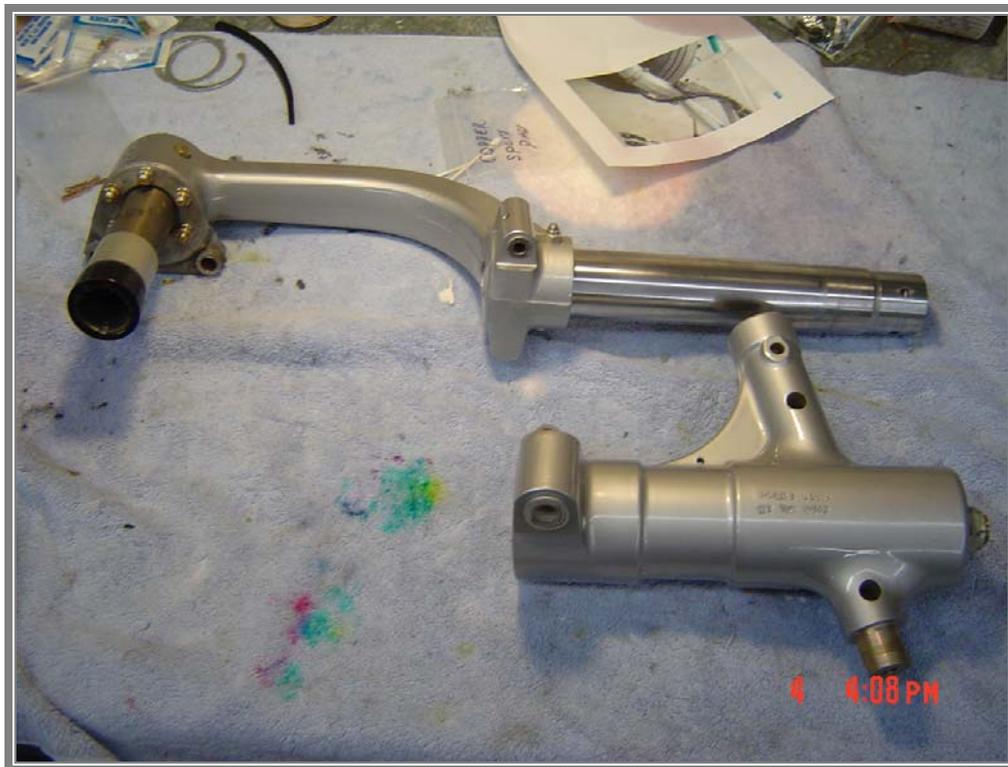
**RIGHT SIDE READY FOR RE-ASSEMBLY; NOTICE THE PRETTY PAINT JOB.**

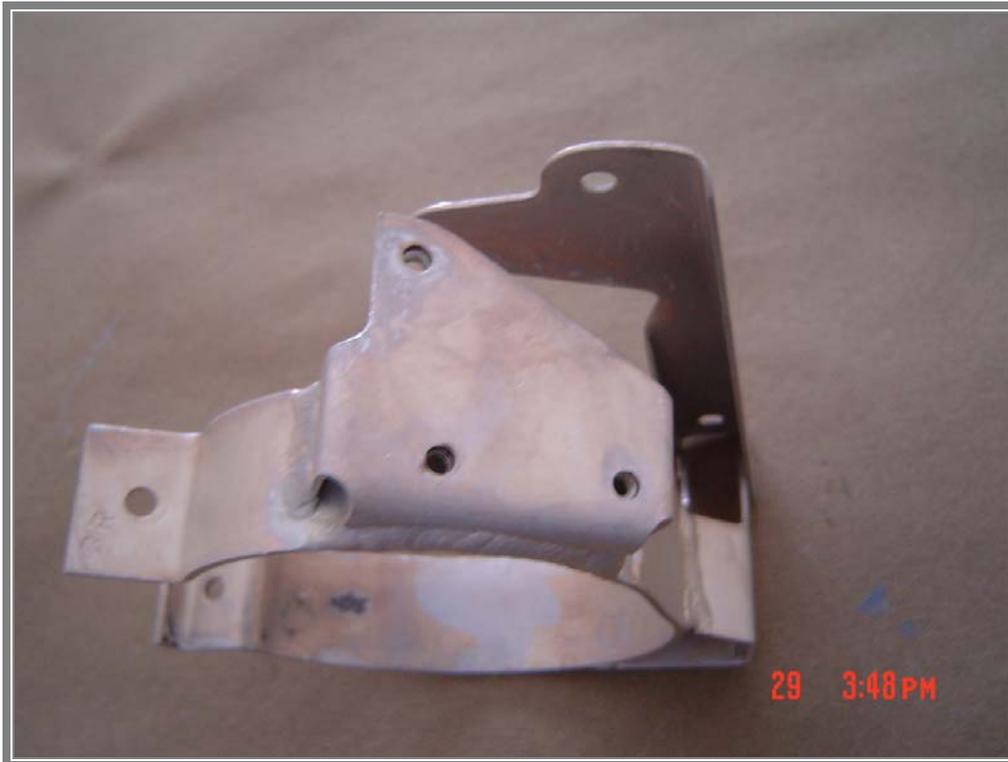
**ONE SAMPLE OF A CADMIUM PLATED COMPONENT AFTER GLASS BEAD BLASTING TO REMOVE ANY CORROSION.**

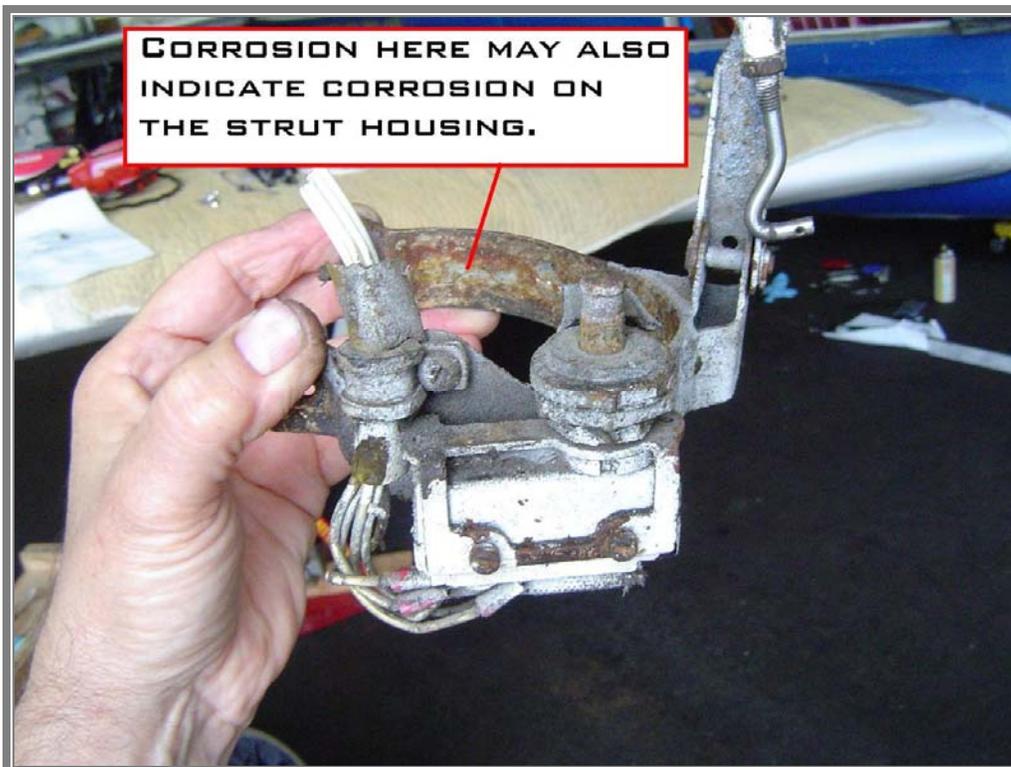
**HERE'S A SIMILAR COMPONENT - NOT MINE. DON'T RE-INSTALL A COMPONENT SUCH AS THIS WITHOUT PROPER CORRECTIVE ACTION.**
