COMANCHE GEAR

MAIN LANDING GEAR SIDE BRACE SUPPORT AND STUD ASSEMBLIES

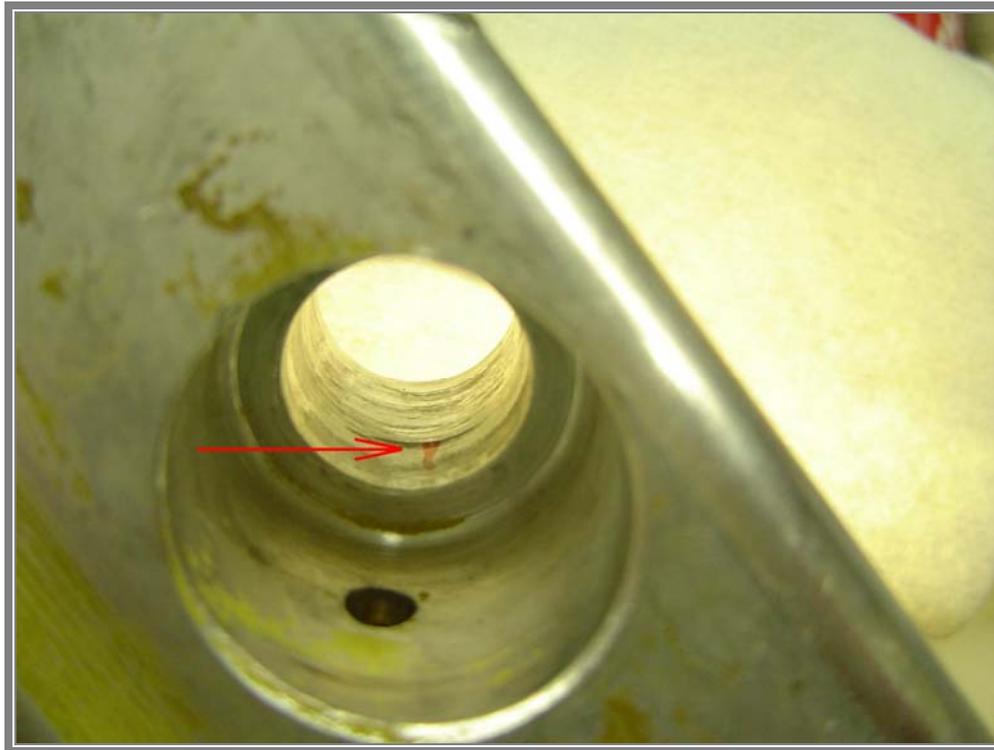
IN THIS PHOTO YOU CAN SEE THE DAMAGED BORE IN THE FORGING; THE RED MARK [ARROW] SHOWS WHERE THE BUSHING WAS “WORKING”. THIS WAS PROBABLY CAUSED BY IMPROPER REMOVAL AND INSTALLATION OF THE NEW BUSHINGS; ALIGNMENT IS CRITICAL DURING ASSEMBLY.

WHEN REPLACING THE BUSHINGS BE AWARE THAT HEATING THE ALUMINUM BEFORE REMOVAL AND INSTALLATION IS IMPORTANT, OTHERWISE IT IS POSSIBLE TO DAMAGE THE FORGING BORE, AND THE RESULT CAN BE THE NEW BUSHING MAY NOT HAVE THE REQUIRED FIT. THESE FORGINGS WERE BRUTALLY EXPENSIVE [\$448] IN 1998 WHEN PIPER DISCONTINUED THEM; BE CAREFUL, THEY ARE CURRENTLY NLA AND YOU MAY BE STUCK WITH AN UNKNOWN SALVAGE PART. ALSO IMPORTANT TO KNOW, AFTER INSTALLATION OF THE NEW **BUSHINGS** IN THE SIDE BRACE SUPPORT, THEY WILL REQUIRE REAMING TO SIZE AND FOR HOLE ALIGNMENT; THAT'S WHY PIPERS' BUSHINGS ARE UNDER-SIZE ON THE I.D. WHY **BUSHINGS** - IT IS INAPPROPRIATE TO REPLACE JUST ONE; YOU WILL NEVER HAVE ALIGNMENT OF THE INTERNAL BORES UNLESS YOU REPLACE BOTH IN ONE BRACKET, FOLLOWED BY THE REAMING OPERATION. YOU MUST REAM THEM OR THE INTERNAL BORES WILL NOT BE IN ALIGNMENT; THINK ABOUT IT! IN ADDITION I USE A HONE AFTER REAMING TO IMPART A CROSS-HATCH FINISH FOR BETTER LUBRICITY.

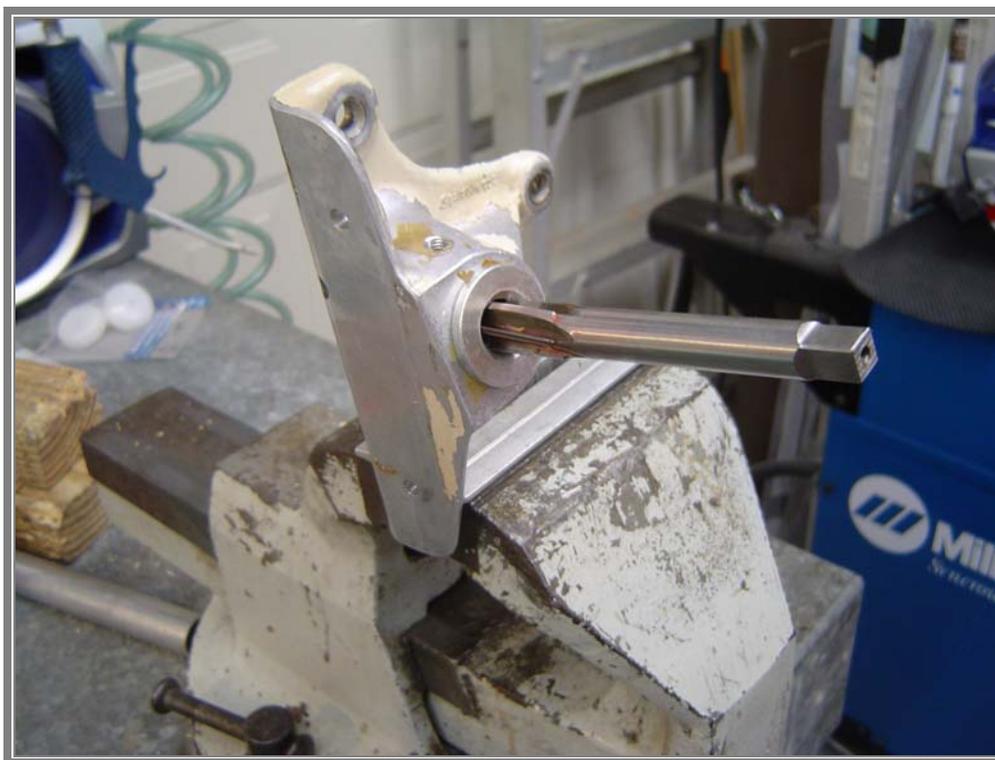
REAMING THE BUSHINGS’ INSIDE DIAMETER TO SIZE AND ALIGNMENT.

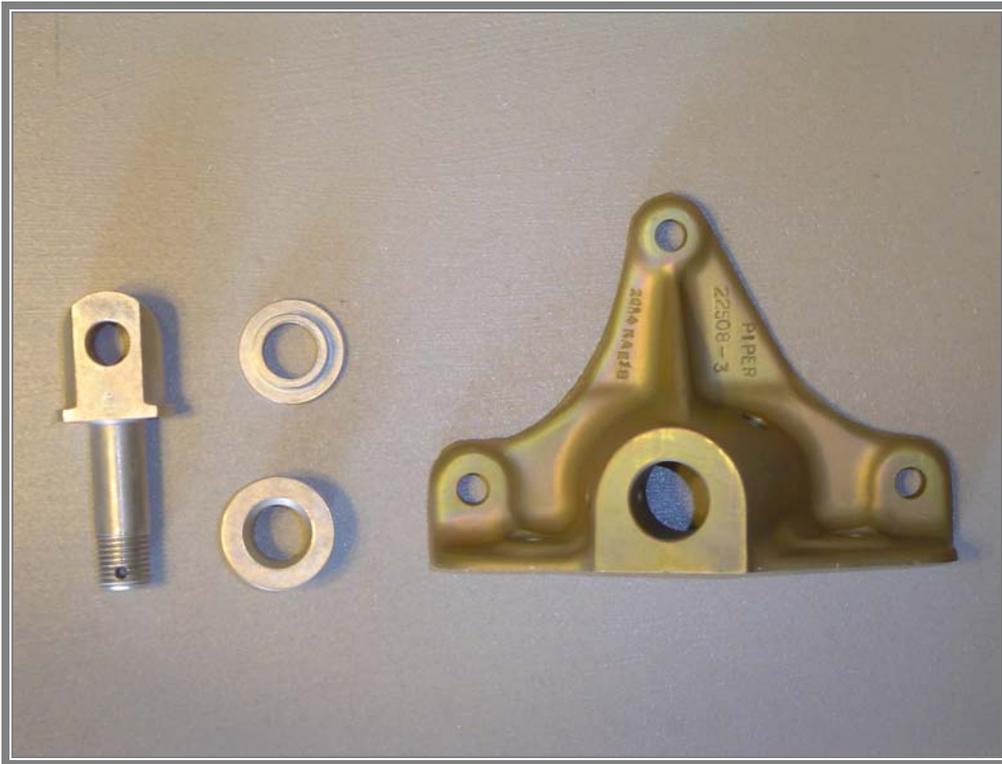
**SIDE BRACE SUPPORT GLASS BEAD BLASTED AND ALDODINE® TREATED;
SIDE-BRACE STUD AD COMPLIED WITH [YT] AND NEW PIPER BUSHINGS.**

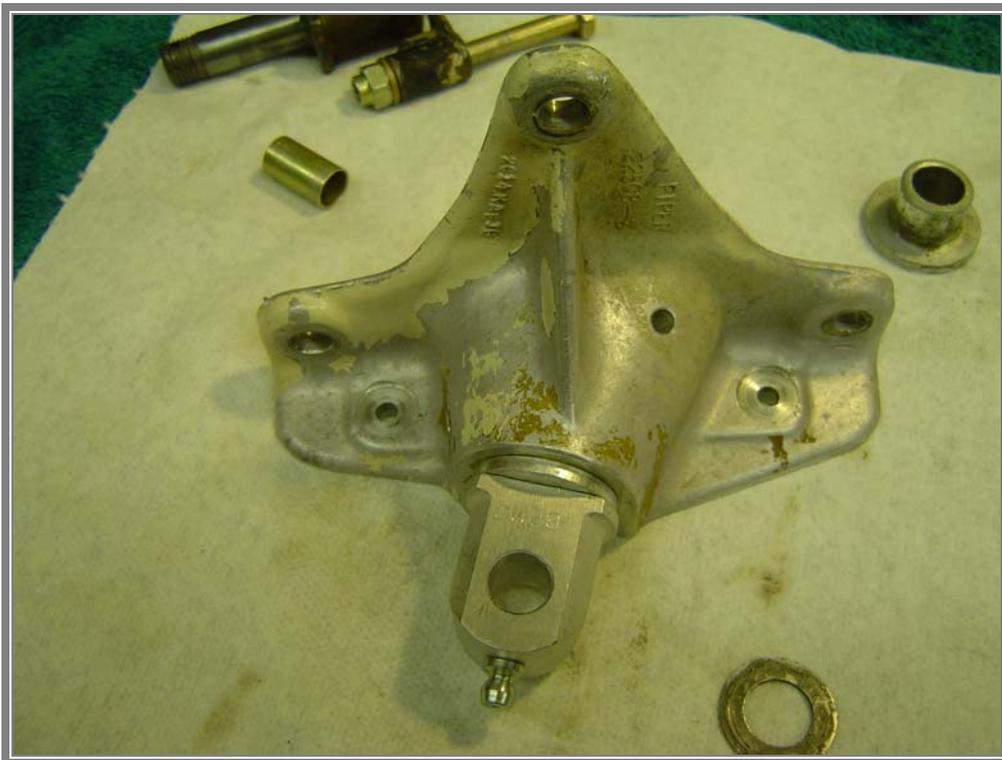
**ANOTHER SIDE BRACE SUPPORT ASSEMBLED AND YELLOW TAGGED;
THIS ASSEMBLY HAS A NEW STUD AND BUSHINGS, NO COSMETICS.**
