# SERVICE LETTER

No. 596A

Piper Aircraft Corporation

Subject: Nose Landing Gear System Product Advancement Information.

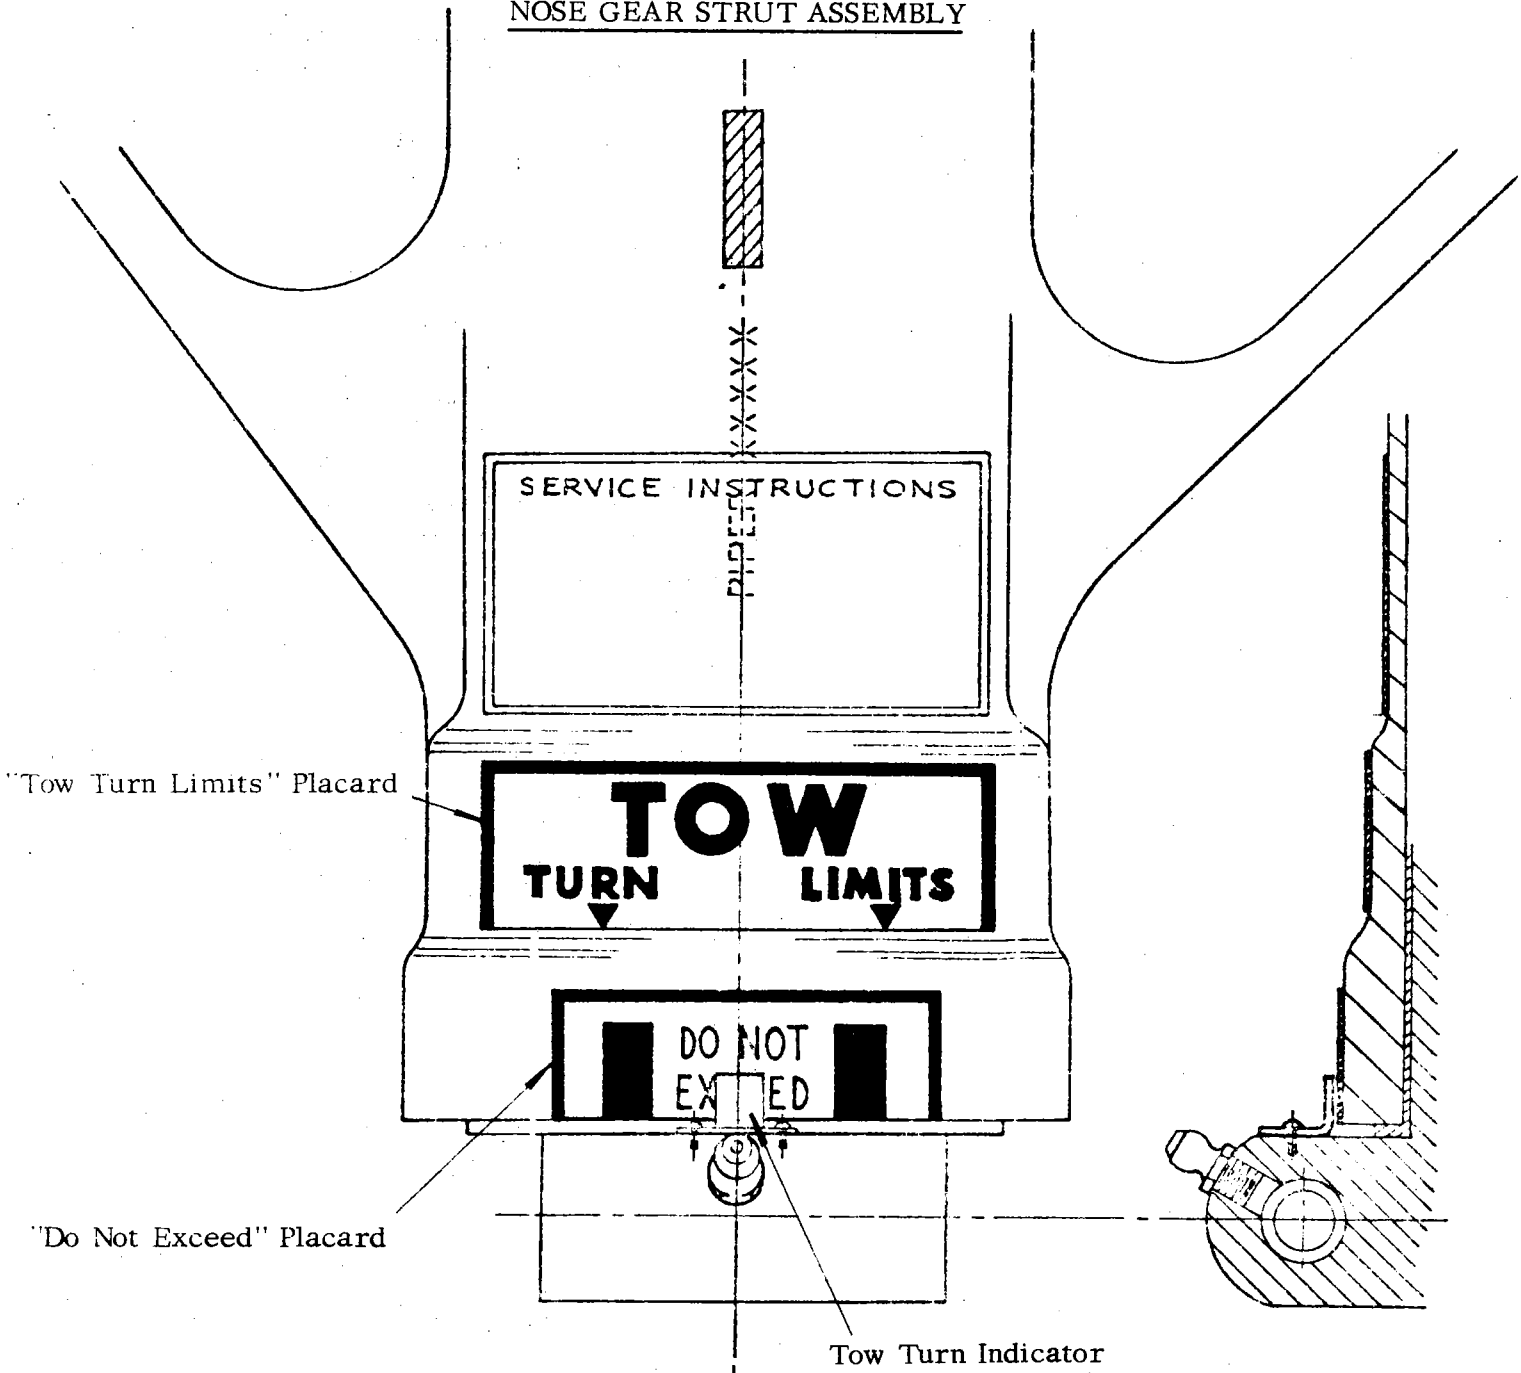
NOSE GEAR STRUT ASSEMBLY

1. Improved nose gear aligner guide bracket assembly.
2. New "High Strength" bolts to attach the nose gear steering arm assembly and the nose gear aligner guide bracket to the nose gear strut housing assembly (refer to attached sketch for a pictorial description).

1. Nose Gear Aligner Guide Bracket Assembly - applies to all aircraft specified in Material Required No. 1, below:
  - a. Inspect existing Nose Gear Aligner Guide Bracket; if guide channel material thickness is .062", replace with new Aligner Guide Bracket Assembly, part number 21719-11. NOTE: It is recommended that the new Aligner Guide Bracket be installed using the new "High Strength" Attachment Bolts, specified below. Prior to installation, check attachment bolt hole size (in Aligner Guide Bracket) to insure .202" diameter, as shown on top portion of attached sketch. .204

- b. If existing Aligner Guide Bracket channel material thickness is .095", remove, ream attachment bolt hole size to .202" diameter (as shown on top portion of attached sketch) .204 and reinstall using new "High Strength" bolts.

Replace Existing Bolts with High Strength Bolts - P/N 402 800 (NAS 1303-8H) (3 Req'd.) Torque 30-35 in. lbs.

Drill and Ream Holes .202 / .204 Diameter
