SERVICE LETTER

No. 667A

Piper Aircraft Corporation

Stabilator Attachment Bolts

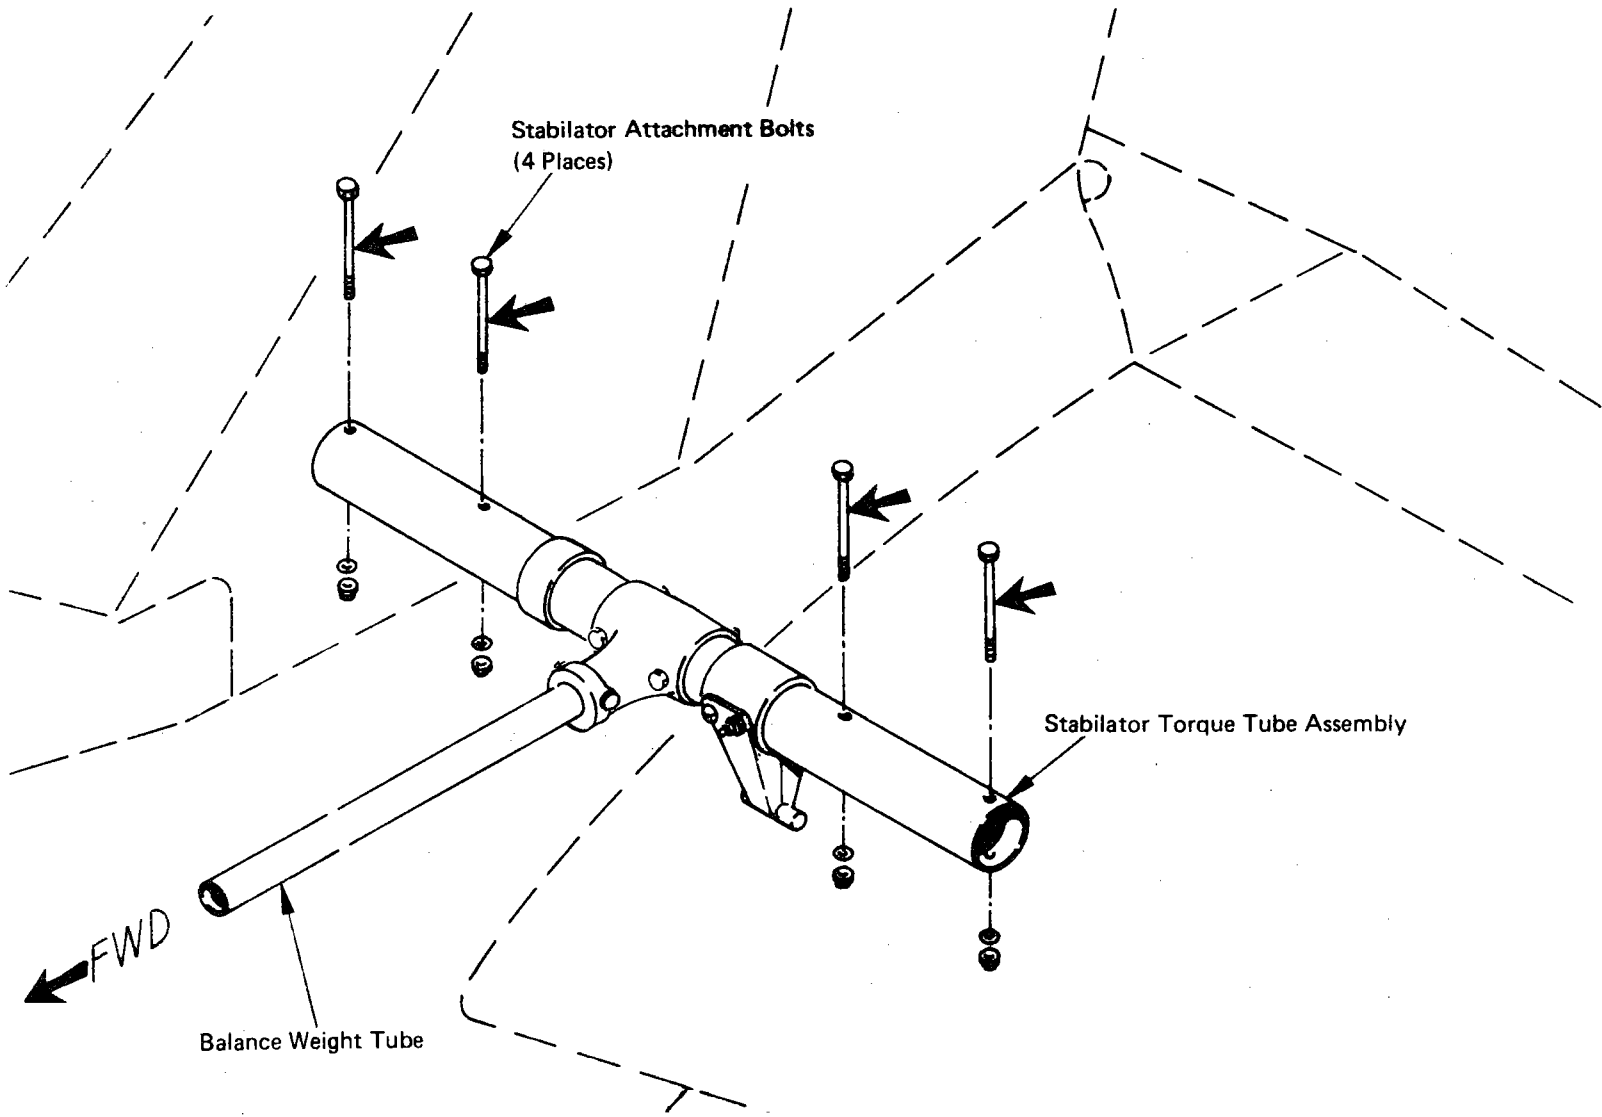
Stabilator Attachment Hardware

It has been determined that the stabilator attachment bolts on the above referenced aircraft may corrode. This situation has occurred primarily on high time aircraft at least five years old and/or operating in areas likely to induce corrosion -- near salt water, etc.

Remove existing stabilator attachment bolts, washers and nuts, indicated on sketch, and install new bolts and attaching hardware. **CAUTION:** Remove and replace one bolt at a time. Refer to sketch for correct replacement hardware identification and proper assembly of bolts, washers and nuts.

2. Correct torque value for bolts is as follows:

- a. PA-24-180/250 and 260 - torque to 30-40 inch lbs.
- b. PA-23-235/250/250 (Six Place) and PA-24-400 - torque to 60-85 inch lbs.
- c. PA-30 - Refer to the Twin Comanche Service Manual (Section 4 - paragraph 49) which states that the nuts ("holding the stabilator to the torque tube") should "be tightened just enough to take the play out of the washers."

- Bolt AN174-C32A P/N 502 329 (Corrosion Resistant) or Bolt AN174-32A P/N 402 329 (Non-Corrosion Resistant)
- Washer AN960-416L P/N 407 585
- Nut MS20365-428C P/N 404 888

- Bolt AN175-C32A P/N 502 342 (Corrosion Resistant) or Bolt AN175-32A P/N 402 342 (Non-Corrosion Resistant)
- Washer AN960-516 P/N 407 566 (PA-23-235/250 and 250 Six Place only)
- Washer AN960-516L P/N 407 586 (PA-24-400 and PA-30 only)
- Nut MS20365-524C P/N 404 889
