SERVICE LETTER

No. 751

Piper Aircraft Corporation

Fin Front Spar Modification.

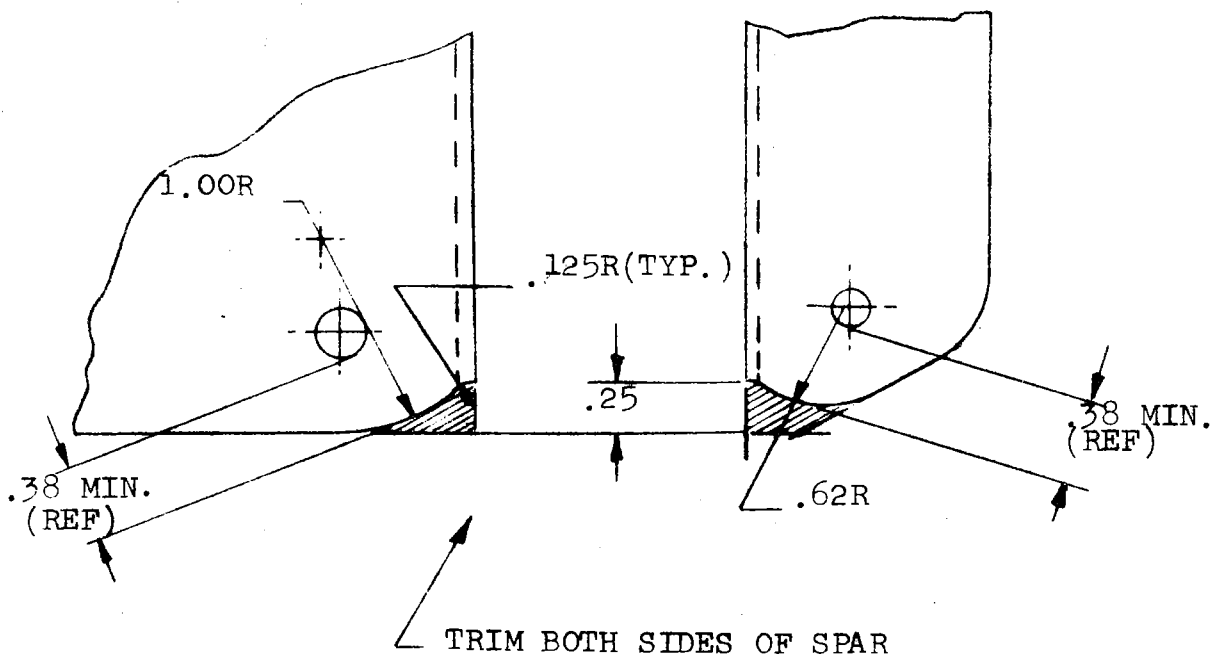
FIGURE 2

Currently, it is necessary to physically remove the fin to gain visual access to the channel relief holes, as the fin front spar extends over the relief holes by approximately 1/2 to 2/3 of the relief hole diameter.

SPAR TRIMMING DETAIL

To eliminate removal of the fin and to enable an easy visual inspection, the fin front spar may be modified in accordance with the sketch/instruction sheet contained on the reverse side of this release.

Refer to "Spar Trimming Detail" on reverse side of this release.
