Service Letter No. 447

SUBJECT: Inspection of Landing Gear Transmission Retract Spring

MODELS AFFECTED: All PA-24 Comanche Series and PA-30 Twin Comanche Series Aircraft

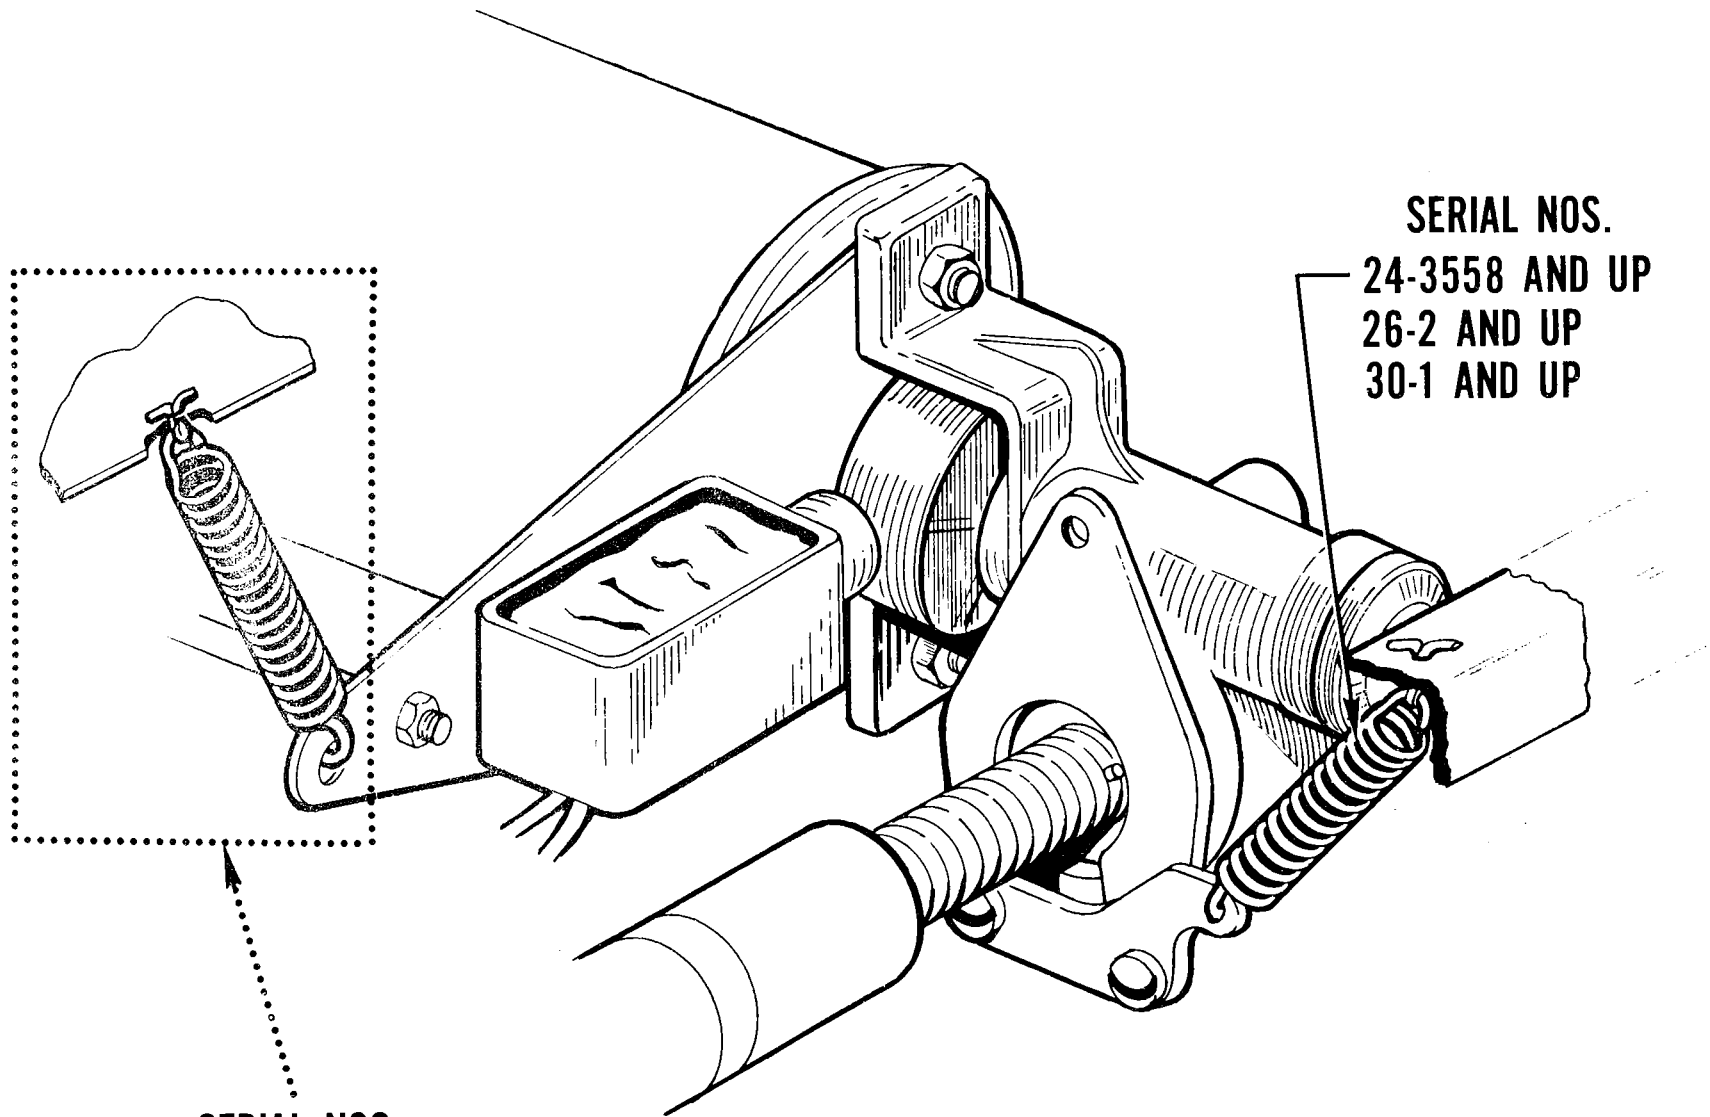
The subject spring is located in the landing gear transmission well and raises the landing gear transmission jack screw to prevent the jack screw from dropping down and interfering with the landing gear mechanism during manual extension of the gear. See sketch on the reverse side of this Service Letter.

SERIAL NOS.
24-3558 AND UP
26-2 AND UP
30-1 AND UP

SERIAL NOS.
24-1 TO 24-3557 INCL.

It is requested that this spring be inspected during routine inspections and, if broken, missing, or not functioning properly, a new spring must be installed.

Replacement springs may be ordered as indicated below:
