Comanche Tail Problems and Cures

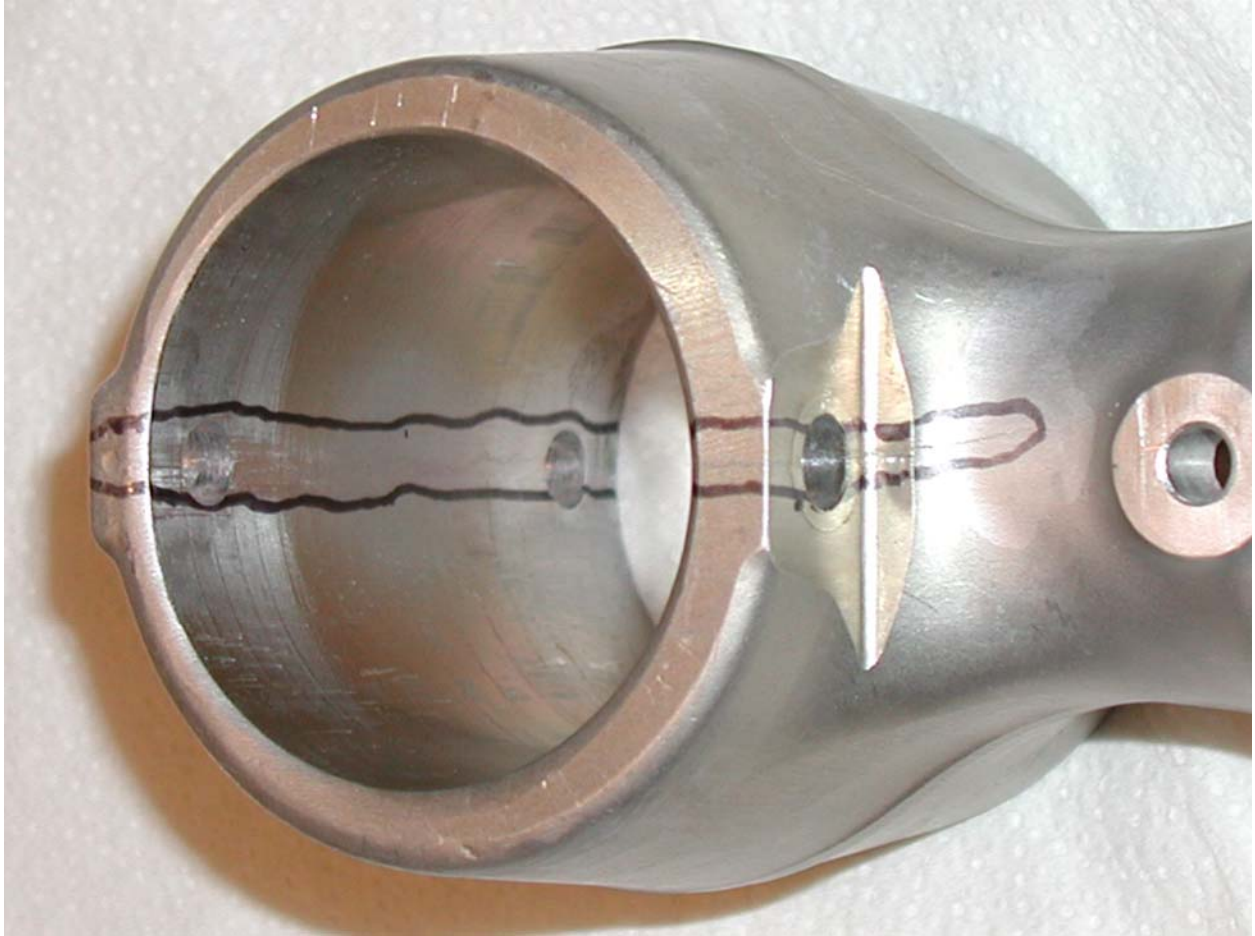
The horn we removed from a 1958 Comanche 250 with 3540 hours was approximately 80% cracked.

View #1 1958 Comanche 250, 3540 hours. Crack visible from outside.

To understand the importance of this, had the crack continued to 100% the horn would have separated into two halves, neither of which would have remained on the job. (The crack was centered through the horn's six bolt holes.) The stabilator balance arm would become detached from the stabilator torque tube resulting in total loss of pitch control from the control yoke. The stabilator would be free to travel up and down from stop to stop without any pilot input. Having lost the counter balance the stabilator would become tail heavy resulting in an airplane pitch down condition. Some control would remain through the trim system; however, if the out of balance condition were to cause flutter followed by stabilator separation, loss of the aircraft would most assuredly follow.

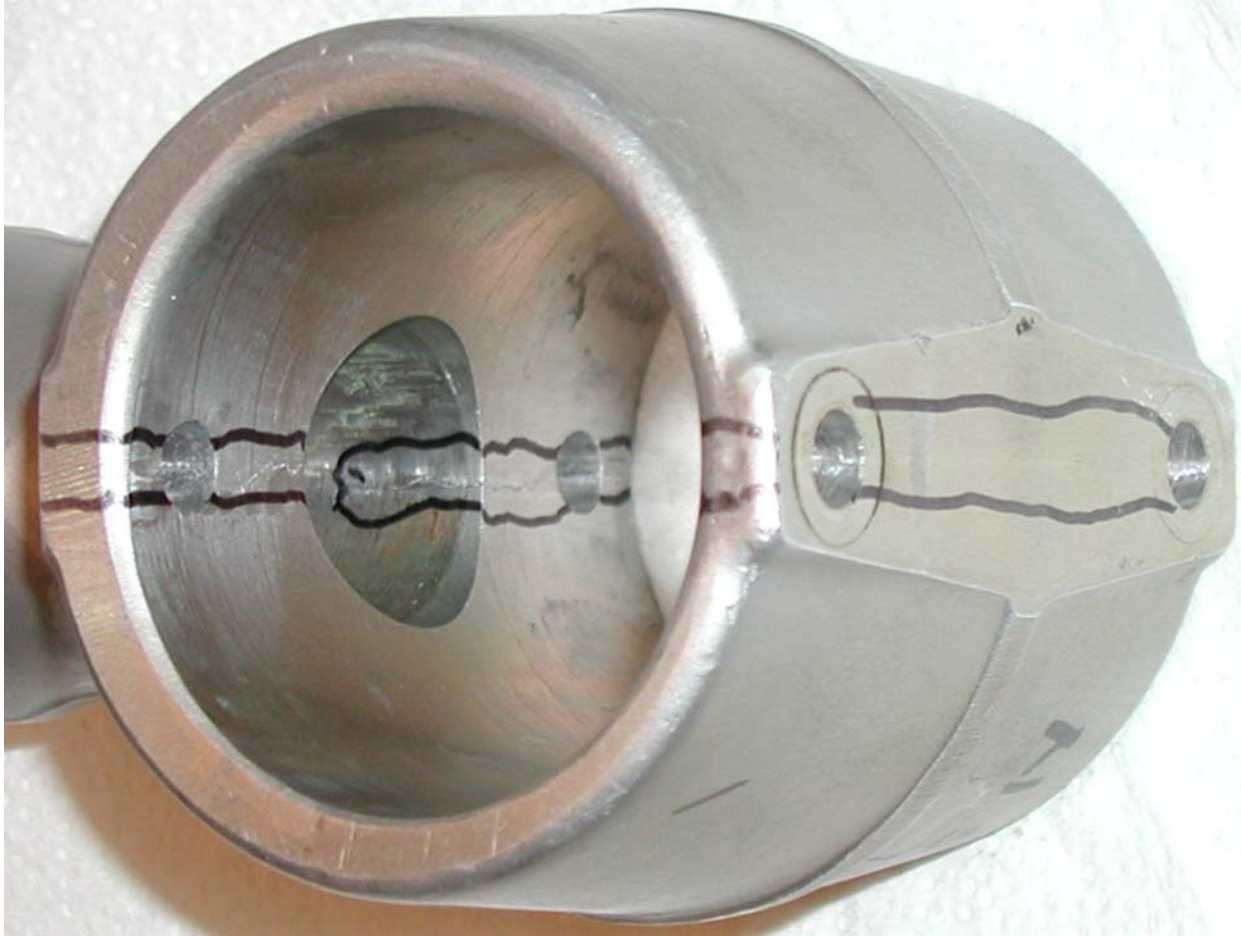
View #2 1958 Comanche 250 3540 hours. Crack visible from outside

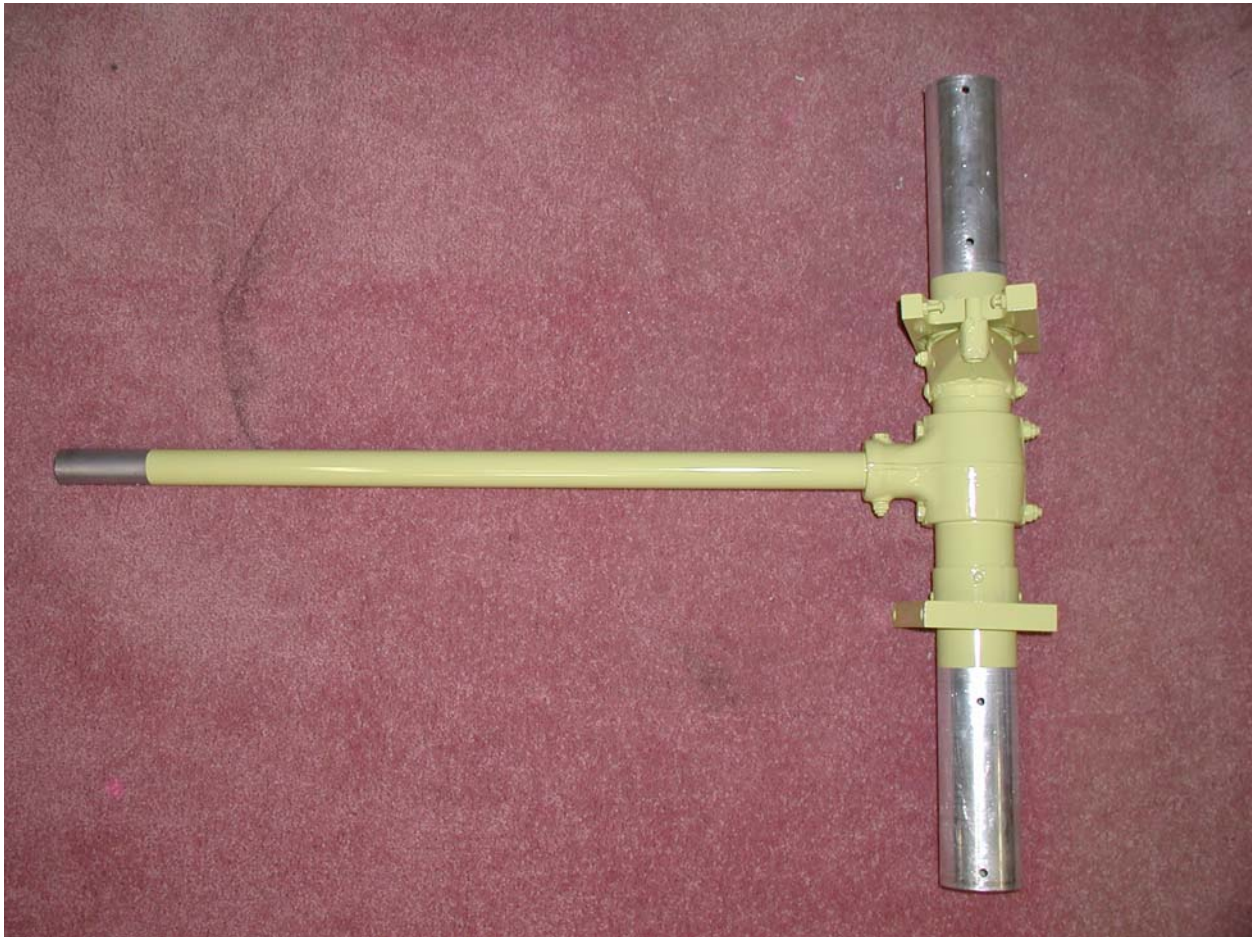
Stabilator Torque Tube Assembly after overhaul and paint

Once disassembled, we remove any paint and foreign material from all parts followed by inspection of the torque tube for cracks, rust, corrosion pitting and any discrepancies. If the tube passes inspection it is sent out for cad plating. Dye penetrant inspection is performed on the aluminum horn checking for cracks. Bearings are disassembled, cleaned and inspected. Many bearings are reusable. Bearings are replaced or repacked with suitable grease and resealed. All attaching hardware is discarded and replaced with new.

After assembly, we paint the entire assembly exterior with epoxy primer and a polyurethane top coat out to the inboard stabilator attach fitting location for protection from exterior rust and pitting.

Then the torque tube is sealed on one end and both tubes are filled with epoxy anti rust primer. The primer is then poured out leaving all the steel hardware and the inside of both steel tubes coated with protection from rust and corrosion. Unless previously treated, your torque tube once had factory Peralketone inside for protection, however, this was ineffective against rust. Most tubes we inspect are raw steel on the inside with light rust.

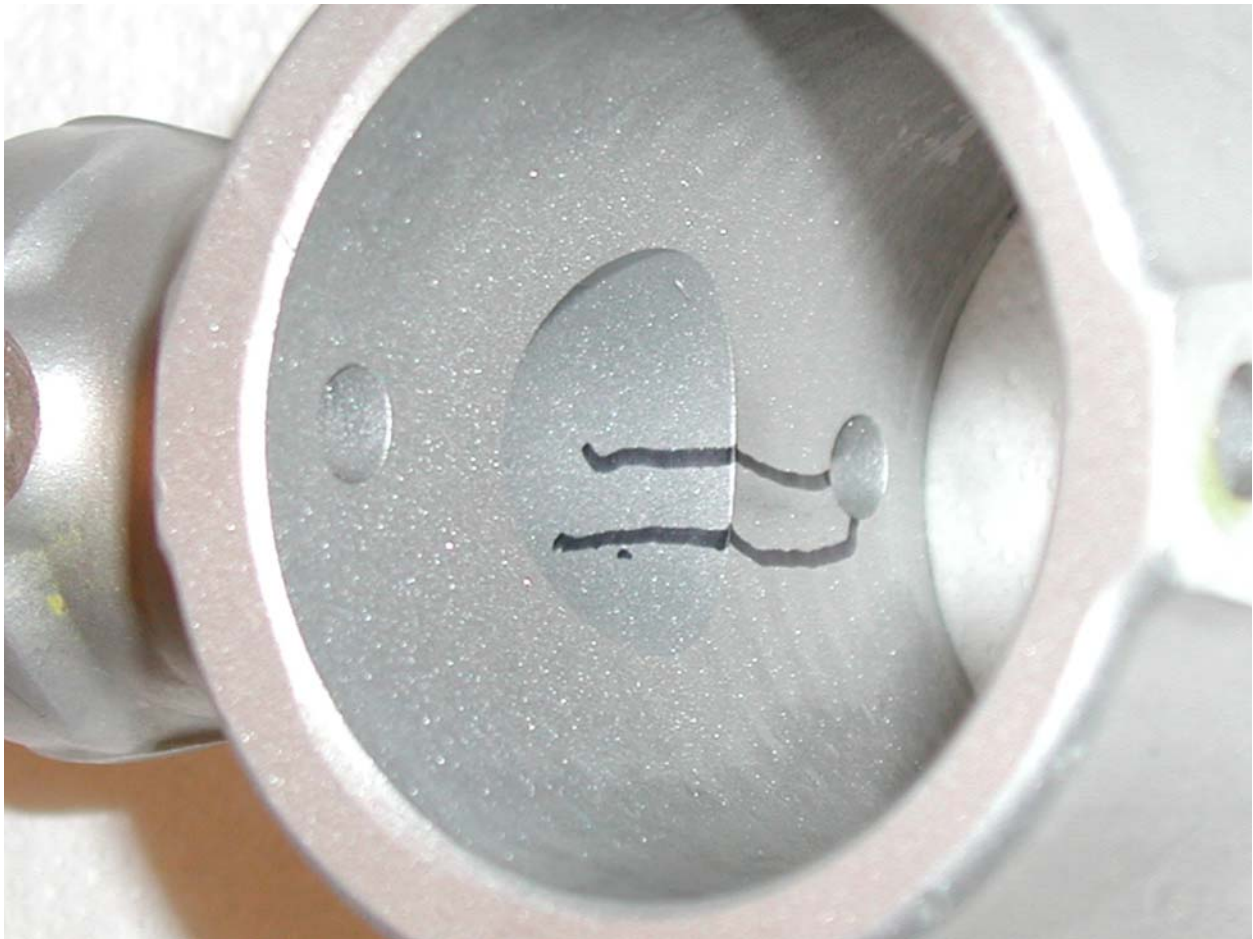
Only one of the three cracked horns we found in 2006 had cracks visible on the outside. All three had cracks in the inside corners of the intersection where the two bores meet. In all three cracked horns the cracks were in alignment with the bolt holes. It should be noted that all three cracked horns we found in 2006 were from mid time airframes. A 1958 with 3540 hours, a 1962 with 3800 hours and a 1964 with 4800 hours. The lowest time airframe of the three with 3540 hours had the most severely cracked horn (approx. 80%).

1962 Comanche 250, 3800 hours. Crack not visible from outside.

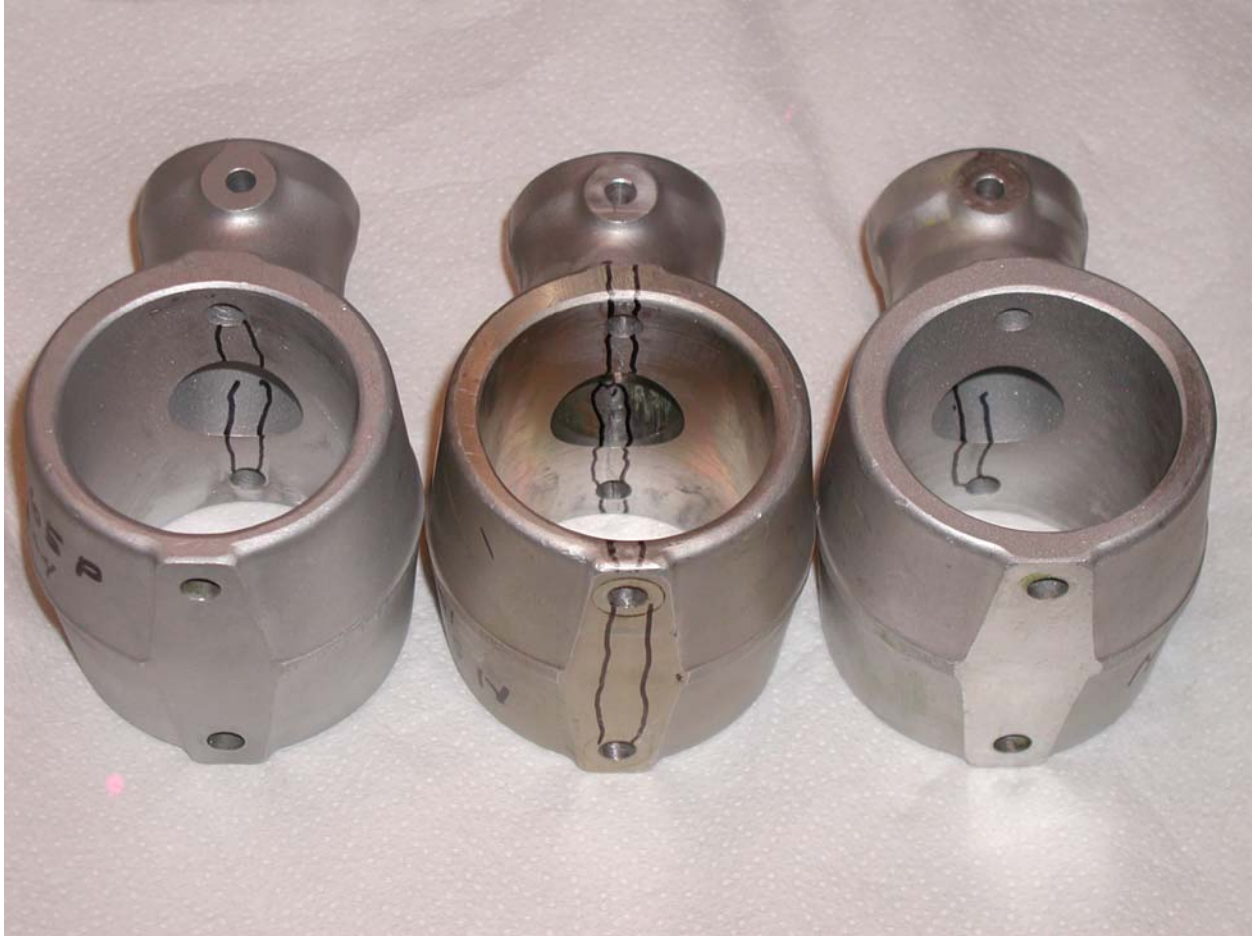
Three cracked horns out of six checked in 2006
Only one crack visible from outside

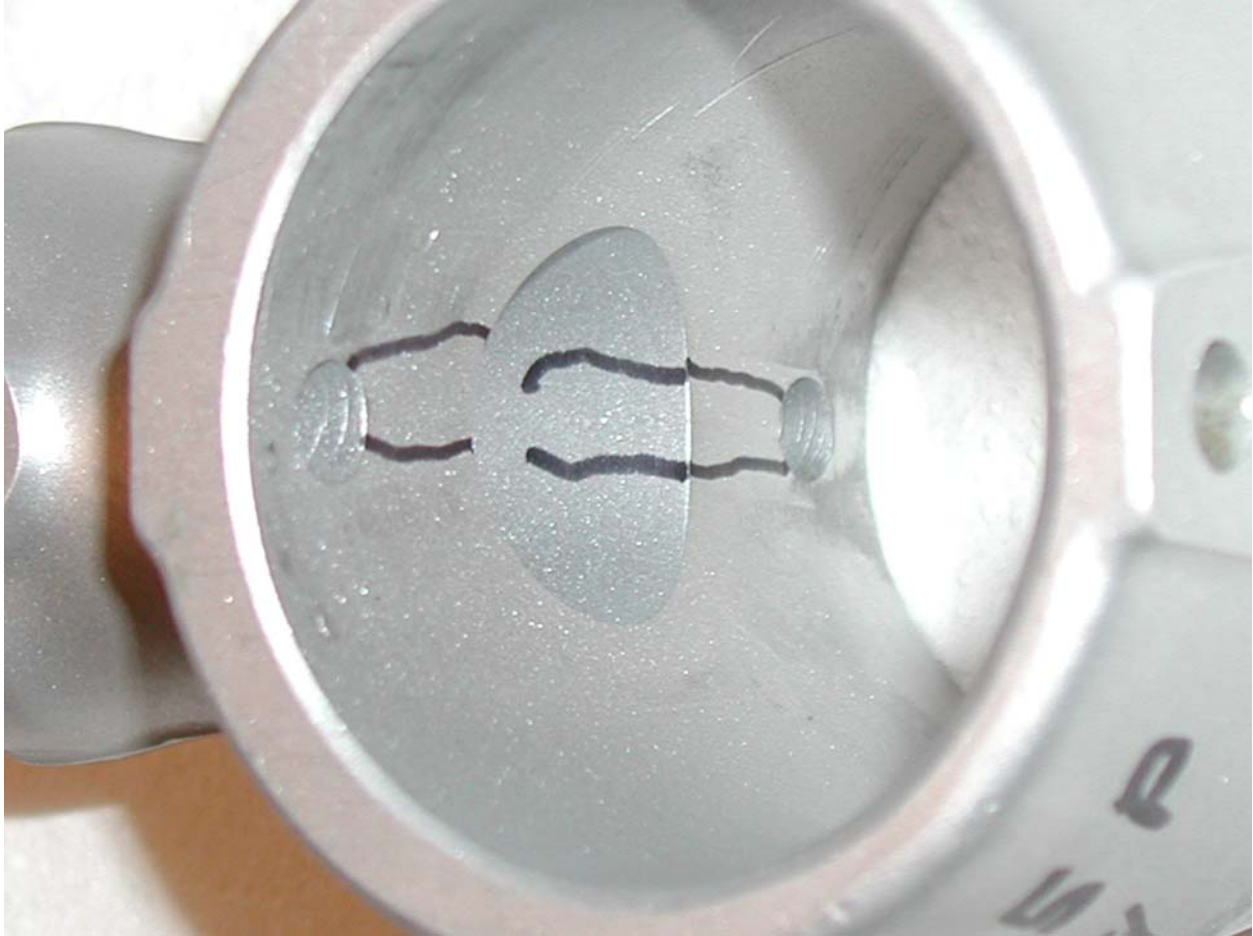
1964 Comanche 180, 4800 hours. Crack not visible from outside.

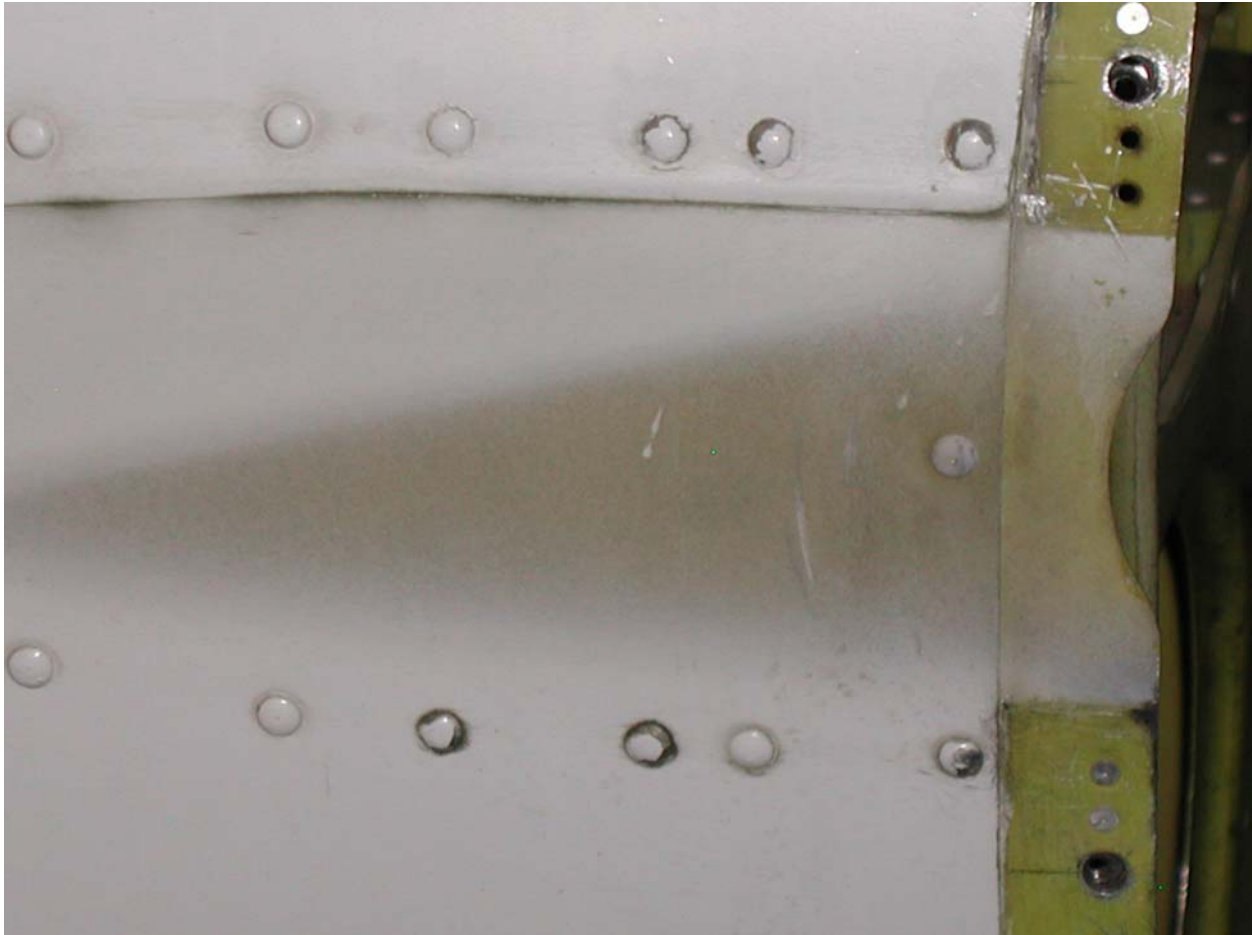
The following photo shows evidence of working (loose) rivets attaching the outer skin to the interior angles that hold the subject attach fittings. The (problem) rivets inside become loose causing movement in the attach fittings. Since the attach fittings are riveted to these angles their movement causes the angles to move resulting in working (loose) rivets through the skin visible on the exterior. If you have chipped paint around these exterior

rivets it's a pretty sure bet the attach fitting rivets inside are also working (loose).

Chipped paint around rivets serves as a working (loose) rivet indicator. These rivets hold angles on the inside upon which the stabilator torque tube bearing support fittings are attached with the (problem) rivets.

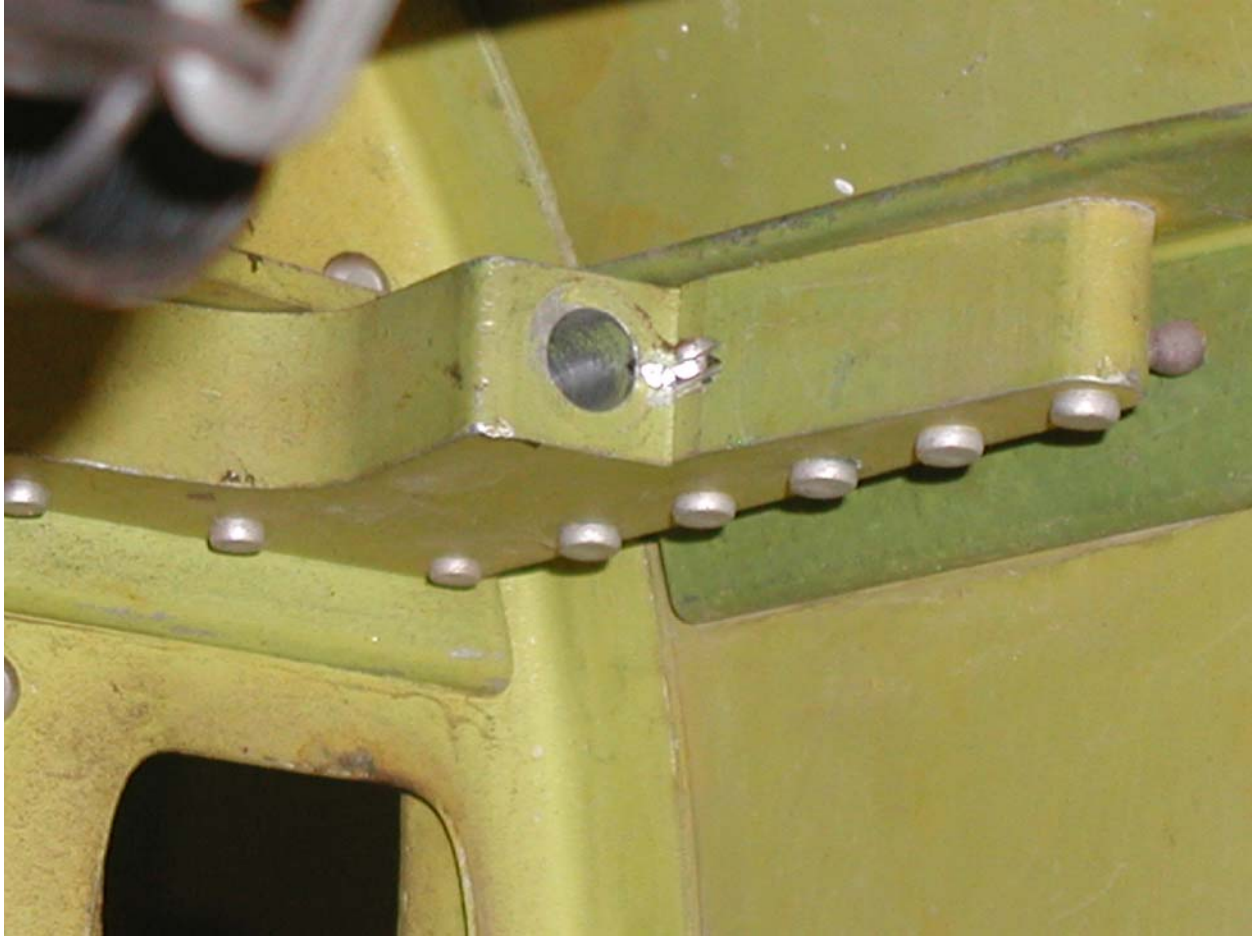
Stabilator torque tube bearing support fitting attached to angle with factory (problem) rivets that are the subject of AD's 75-27-08 & 94-13-10. The rivets with chipped paint on the exterior are located behind this fitting. One rivet is visible to the right of the fitting.
