SERVICE BULLETIN

No. 411A

Piper Aircraft Corporation

Subject: Stabilator Torque Tube Bearing Block Attachment Fitting Rivet Replacement

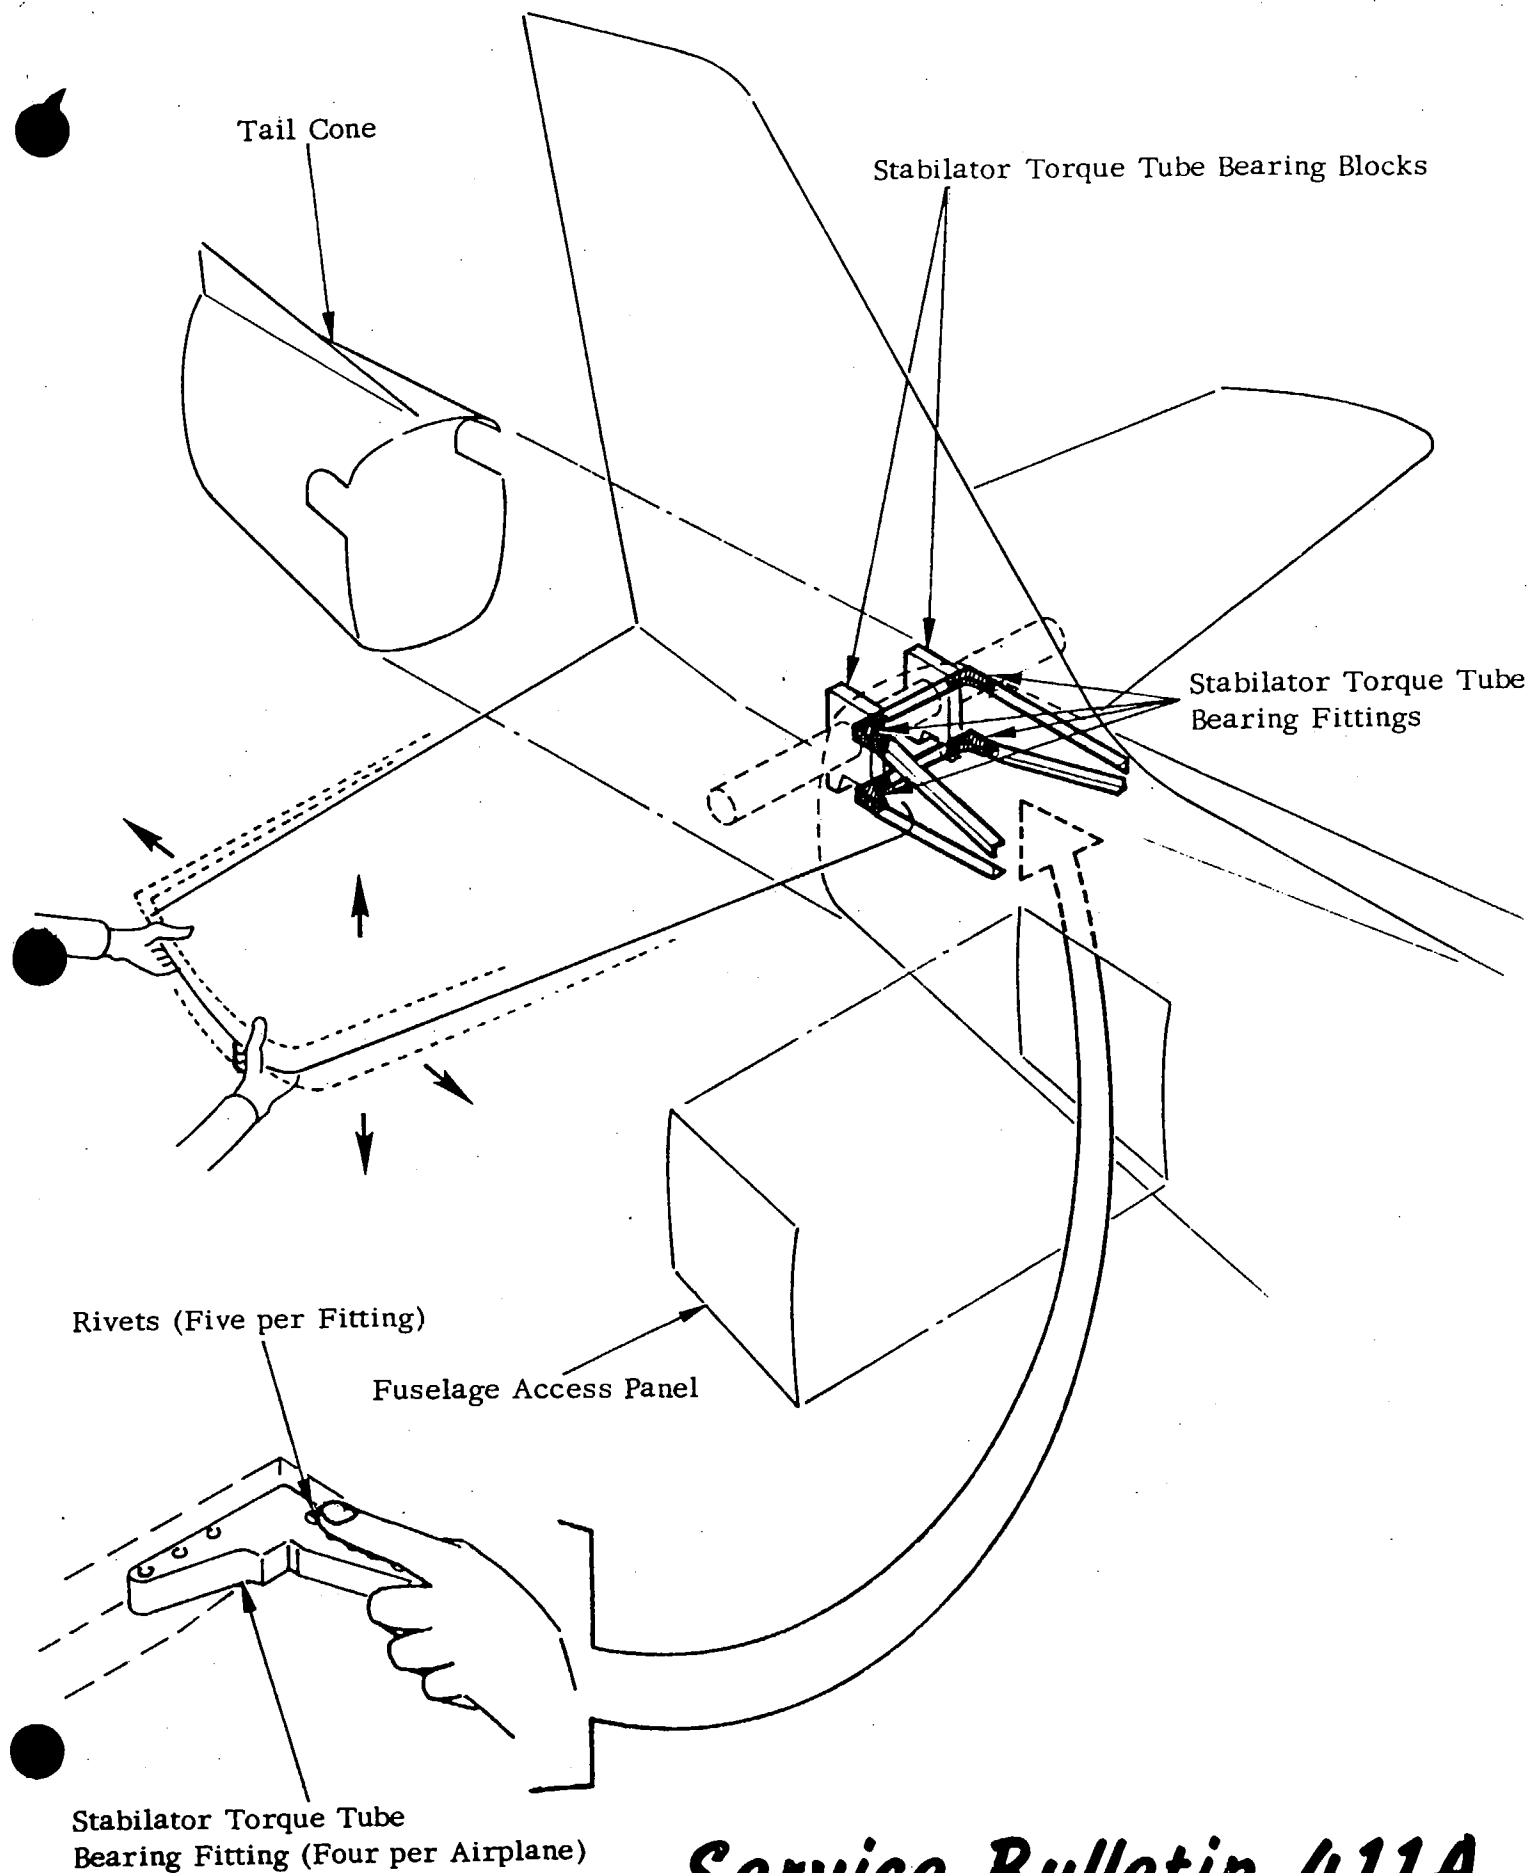
Service Bulletin 411A

Purpose: Information has been received by the factory describing movement and/or noise in the area where the stabilator assembly joins the fuselage. It has been determined that the above described condition may have been caused by one of the following (refer to attached sketch for a pictorial description of the affected areas):

1. Stabilator torque tube bearings not firmly seated in the stabilator torque tube bearing blocks.
2. The holes in the stabilator torque tube bearing upper and lower fittings may be enlarged.

2. Simultaneously (with Step 1, above), have another person check closely for movement and/or noise in the area described in Purpose, above (the attached sketch illustrates a recommended method of detecting movement in the stabilator torque tube bearing fittings area).
3. If there are no indications of movement and/or noise, no further action is required (other than log book entry).
4. If there is movement and/or noise in the area described in Purpose, above, immediately contact the Customer Services Department, Piper Aircraft Corporation, Lock Haven, Pennsylvania 17745.
