SERVICE BULLETIN

No. 464A

Piper Aircraft Corporation

Subject: Inspection of Stabilator Torque Tube Bearing Block Attachment Fitting Rivets.

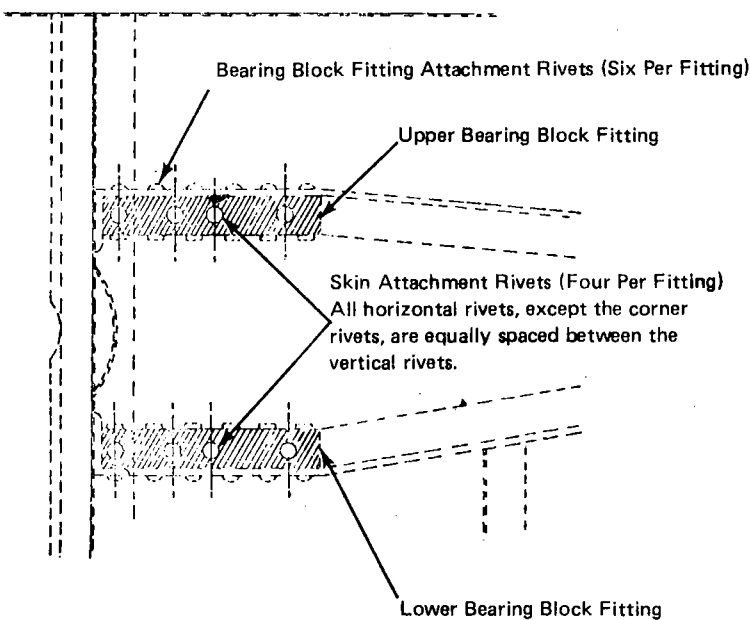
VIEW A-A: CORRECT RIVET ALIGNMENT

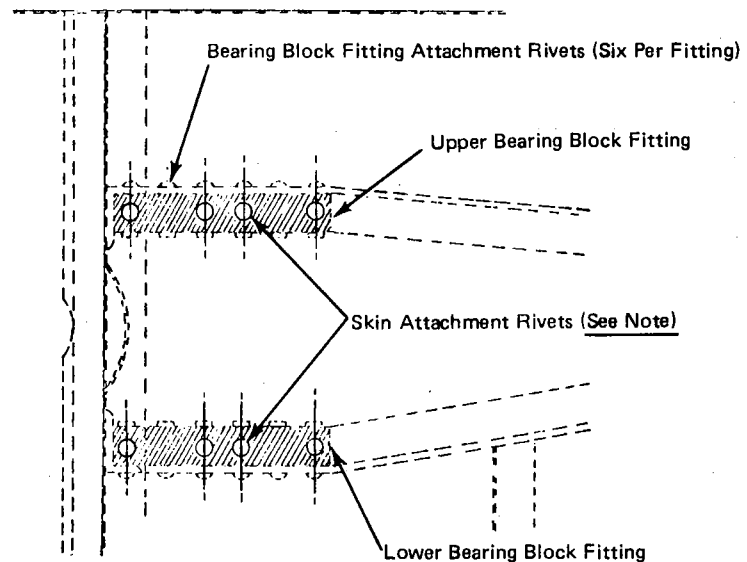
Stabilator Bearing Block Attachment Fitting Rivets (see sketch for an illustration of this condition).

VIEW A-A: RIVET ALIGNMENT which may have resulted in rivet penetration:

NOTE: All horizontal rivets, except the corner rivets, are incorrectly installed in this view as they are aligned with the vertical rivets. If more than two rivet alignments are evident in each fitting, it will be necessary to install Kit 760 835.

1. One (1) each PER FITTING (i.e., each kit contains sufficient material to modify one only Stabilator Torque Tube Bearing Block Fitting), Piper Kit Number 760 835, Hi Shear Rivet Replacement, if required per Instructions number 3, above.
2. Two (2) each per aircraft Cover Plate, Part Number 28216-02, if installation of Kit 760 835 is required per Instructions number 3, above.
