SPECIAL AIRWORTHINESS INFORMATION BULLETIN

CE-04-88
September 15, 2004

This Special Airworthiness Information Bulletin (SAIB) alerts you, owners and operators of **The New Piper, Inc. PA-23, PA-24, PA-30, and PA-39 aircraft**, of potential corrosion of the stabilator torque tube, attached fittings, and attaching fasteners.

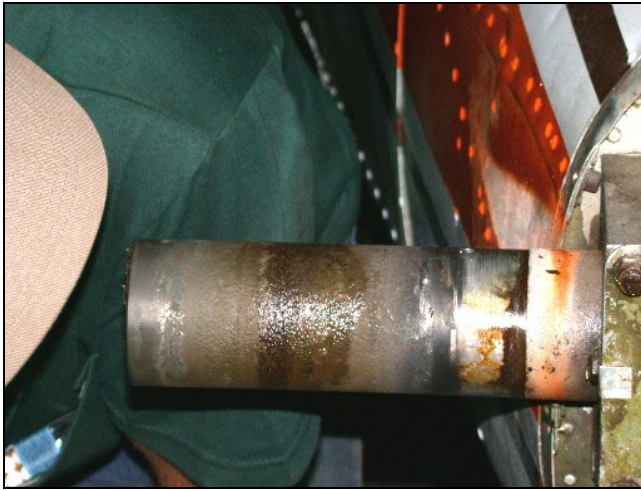
There is a possibility of corrosion in the stabilator torque tube, attached fittings (horn and balance weight), and attaching fasteners (bolts) on all subject aircraft listed above. The corrosion is in an area that may not be readily accessible and may progress undetected. Failure of the subject parts may lead to a loss of pitch control.

Corroded Torque Tube (PA-24)

Disassemble and clean parts, as required, to inspect the following for corrosion or other signs of distress (i.e. elongated holes):

- Internal and external bore of the torque tube.
- Balance weight fitting, including internal bore.
- Control horn, including internal bore (same as balance weight fitting on PA-23 models).
- All fasteners common to the tube assembly. You are also encouraged to inspect the surrounding area for evidence of corrosion, cracking, elongated holes and other signs of distress. ADs and Piper service documents pertaining to the local area should also be identified and reviewed for compliance.

If you find corrosion, replace or repair the damaged parts. See Advisory Circular (AC) 43.13-1B, Acceptable Methods, Techniques, and Practices-Aircraft Inspection and Repair, and AC 43-4A, Corrosion Control for Aircraft for corrosion removal procedures.

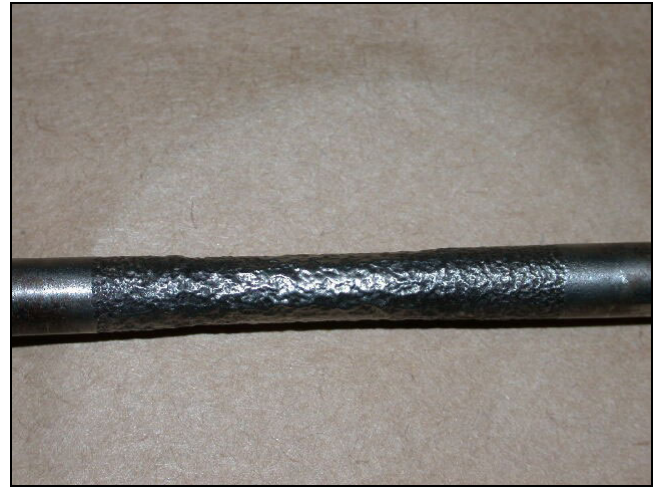
Corroded Attach Bolt
