Service Letter No. 370

SUBJECT: Modification to Engine Breather Line

MODELS AFFECTED: PA-24 and PA-24 "250" Comanches - Serial Numbers 24-2175, 24-2299 to 24-2675 incl., 24-2677 to 24-2801 incl., 24-2803, 24-2804, 24-2806, 24-2808 to 24-2888 incl., 24-2890 to 24-2935 incl., 24-2937, 24-2939 to 24-2943 incl., 24-2945 to 24-2948 incl., 24-2950 to 24-2956 incl., 24-2958 to 24-2966 incl., 24-2969 to 24-2982 incl., 24-2984, 24-2986 to 24-2989 incl., 24-2991, 24-2992, 24-2994 to 24-3005 incl., 24-3007 to 24-3009 incl., 24-3011, 24-3012, 24-3014, 24-3016, 24-3018, 24-3020 to 24-3023 incl., 24-3027 to 24-3040 incl., 24-3042, 24-3043, 24-3046 to 24-3049 incl., 24-3052, 24-3055, 24-3059, 24-3060, 24-3062, 24-3068.

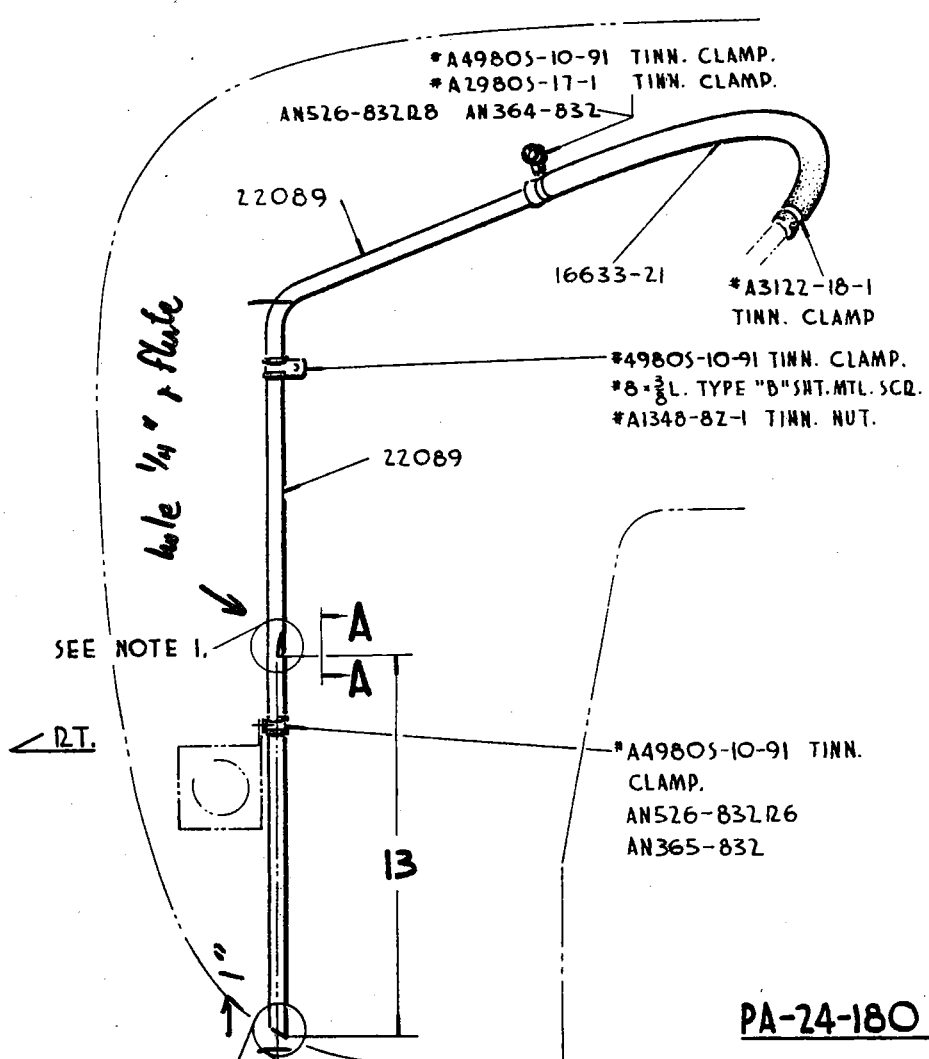
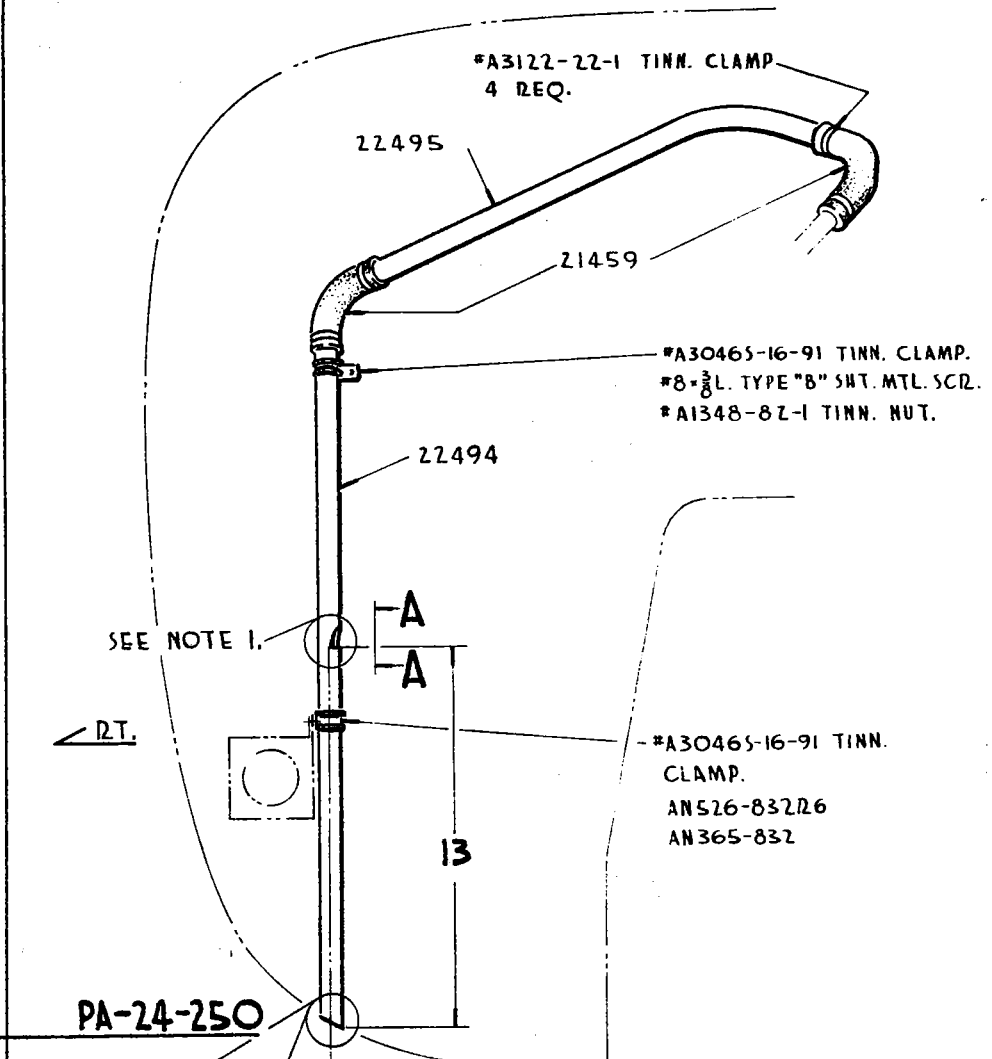
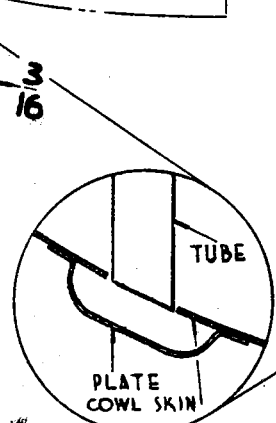
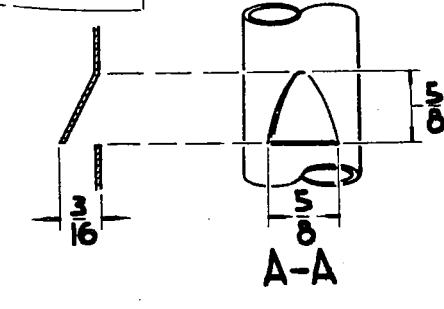
# SERVICE LETTER NO 370

A few reports have been filed with the Service Department indicating that the engine breather line on the subject aircraft may extend below the opening in the bottom cowl.

The engine breather line should be inspected and, if necessary, adjusted so that it is flush with the bottom cowl. Refer to sketch on the reverse side of this Service Letter. The adjustment of this breather line, flush with the bottom cowl, will prevent the accumulation of ice at the opening of the engine breather line and in the scoop into which it vents.

As a precautionary measure, for operations in extensive icing conditions it is recommended that the engine breather line be modified to provide an alternate vent. This modification consists of a saw-cut across the engine breather line and forming the area above the saw-cut as shown in the sketch on the reverse side of this Service Letter.

NOTE: CARE SHOULD BE EXERCISED WHILE FORMING THE VENT  
SO THAT THE TUBE IS NOT FLATTENED OR DISTORTED.

1. REMOVE BURRS THAT MAY BE FORMED AT END OF SAW SLOT.
2. ADJUST OIL BREATHER TUBE FLUSH WITH SKIN.
