SERVICE LETTER

No. 650

Piper Aircraft Corporation

Inspection of Landing Gear Retraction and Flap Control Transmission Assemblies

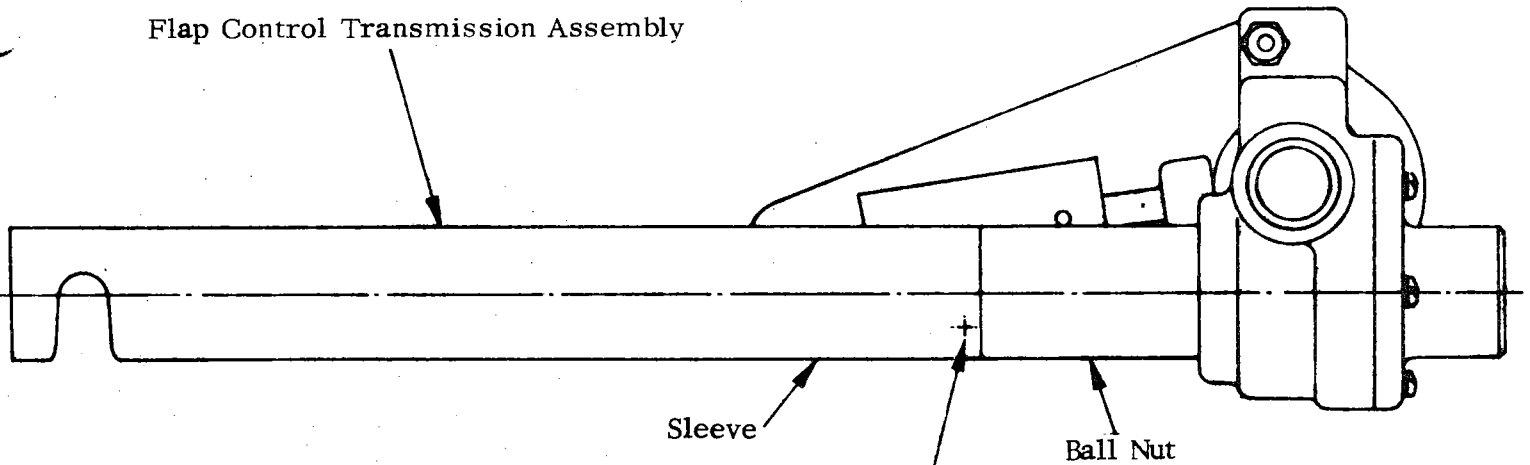
Flap Control Transmission Assembly

Sleeve must be staked at three points
(on circumference of sleeve) to prevent
separation of threaded joint.

1. Refer to the appropriate Service Manual and gain access to the flap control transmission (if installed) and the landing gear retraction transmission.
2. Inspect transmissions to determine if sleeve has been properly staked as shown on above sketch.
3. If the transmission sleeves have been properly staked, no further action is required.
4. If either of the transmission sleeves have not been staked, it will be necessary to remove the transmission from the airplane and stake as shown (sleeve must be tight against ball nut before staking). Use a center punch and carefully stake to a depth of .030 to .040 inches. Refer to the appropriate Service Manual for proper Removal and Installation Procedures.
