COMANCHE GEAR

400 COMANCHE INDUCTION HOUSING

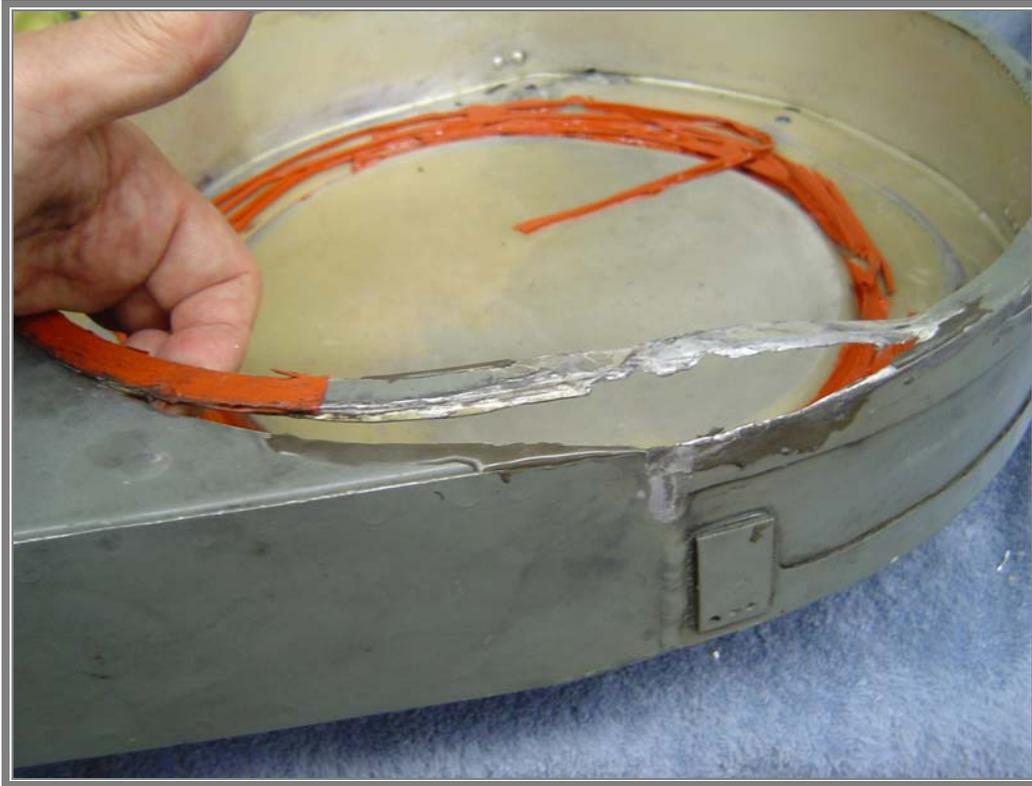
THE 400 COMANCHE INDUCTION HOUSING ASSEMBLY CONSISTS OF TWO SUB ASSEMBLIES, 24568-000 THE BOX ASSEMBLY AND 24569-000 THE PLATE ASSEMBLY. BOTH OF THESE PART NUMBERS HAVE BEEN DELETED FROM PIPER'S AVAILABILITY LIST; THEIR 1999 PRICING WAS \$1800 AND \$550. THESE COMPONENTS TEND TO SUFFER THE RIGORS OF FRETTING, CRACKING AND FROM LACK OF MAINTENANCE TO THE CAMLOC® LATCHES WHICH CLAMP THE TWO COMPONENTS TOGETHER. THIS POOR CLAMPING RETENTION LEADS TO FURTHER FAILURE AND SUBSEQUENTLY A POSSIBLE POOR CHOICE OF REPAIR METHOD, THE THROUGH-BOLT METHOD IS ONE. TYPICALLY BOTH PIECES REQUIRE SUBSTANTIAL WORK AFTER 42+ YEARS OF FRETTING DAMAGE.

24568-000 BOX ASM, AS RECEIVED.
NOTICE THE PRIOR "REPAIRS" USING EPOXY AND SILICONE

THE PLATE ASSEMBLY WILL BE REPAIRED AND REINFORCED TO BETTER SUPPORT THE BOX ASSEMBLY AND THE BOX ASSEMBLY ITSELF REPAIRED AS NECESSARY. ADDITIONAL SEALING AND VIBRATION/FRETTING RESISTANCE ARE ADDED USING SILICONE FOAM RUBBER BETWEEN THE TWO COMPONENTS AT THE MATING SURFACE AND THIN ANTI-CHAFE TAPE AT THE BOX CIRCUMFERENCE. SO FAR I HAVE BEEN ABLE TO PURCHASE THE CAMLOC® LATCH ASSEMBLIES AND STRIKES THAT PIPER ORIGINALLY USED, ALTHOUGH REPORTEDLY THEY HAVE BEEN DISCONTINUED, SO WHO KNOWS WHAT THE FUTURE BRINGS IN THAT DEPARTMENT.

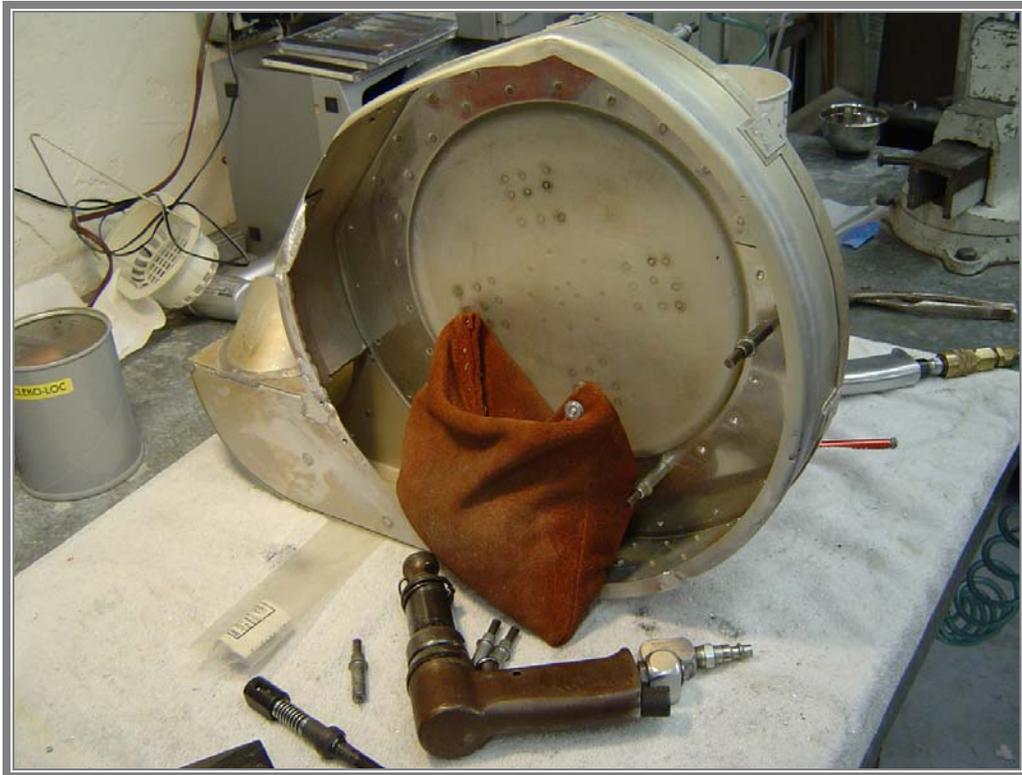
24568-000 BOX, TYPICAL REPAIR PROCESS

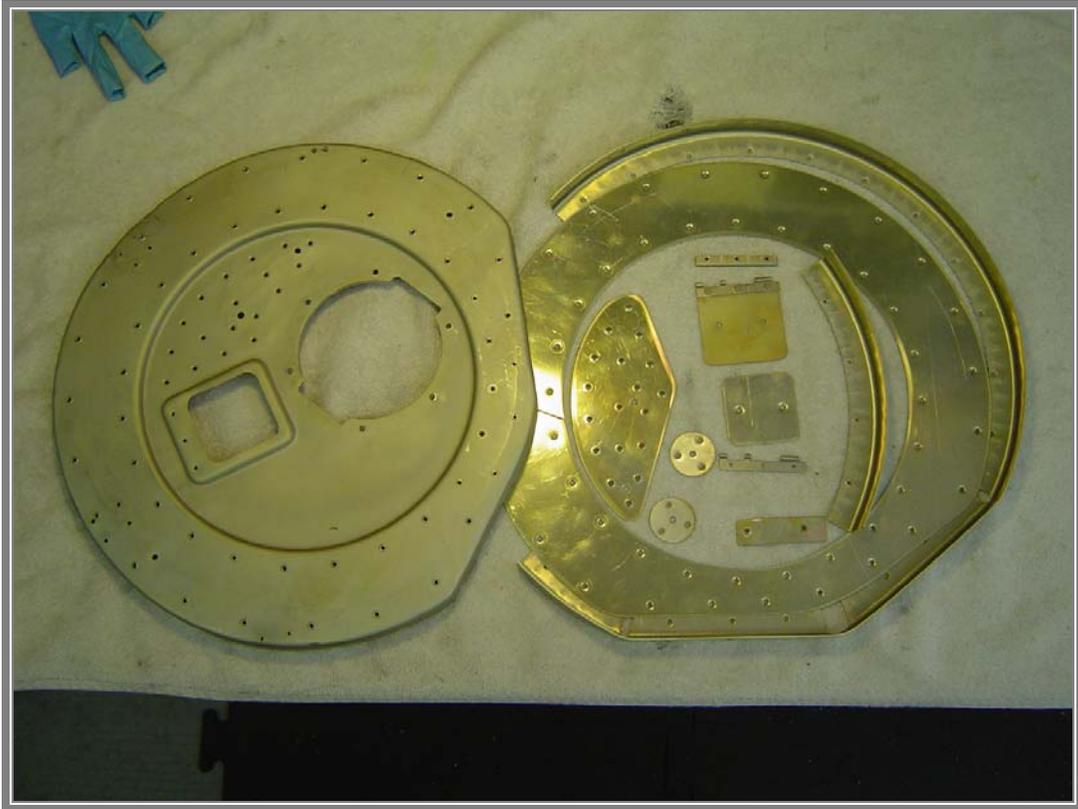
24569-000 PLATE, TYPICAL REPAIR COMPONENTS

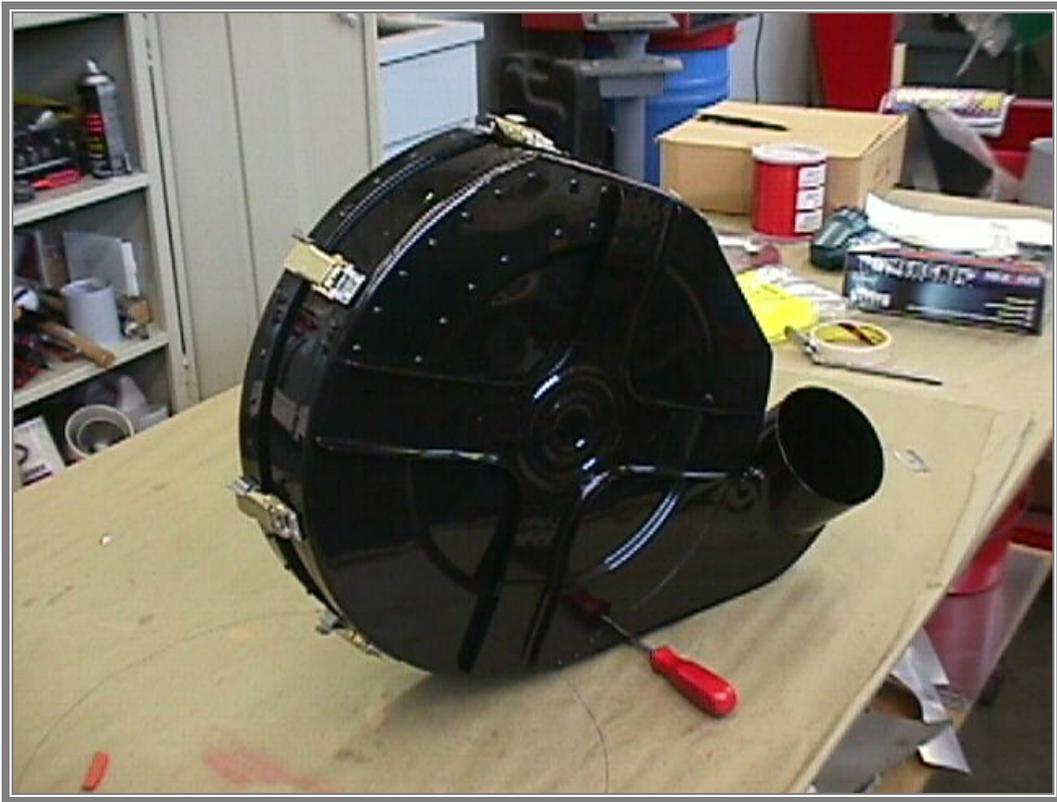
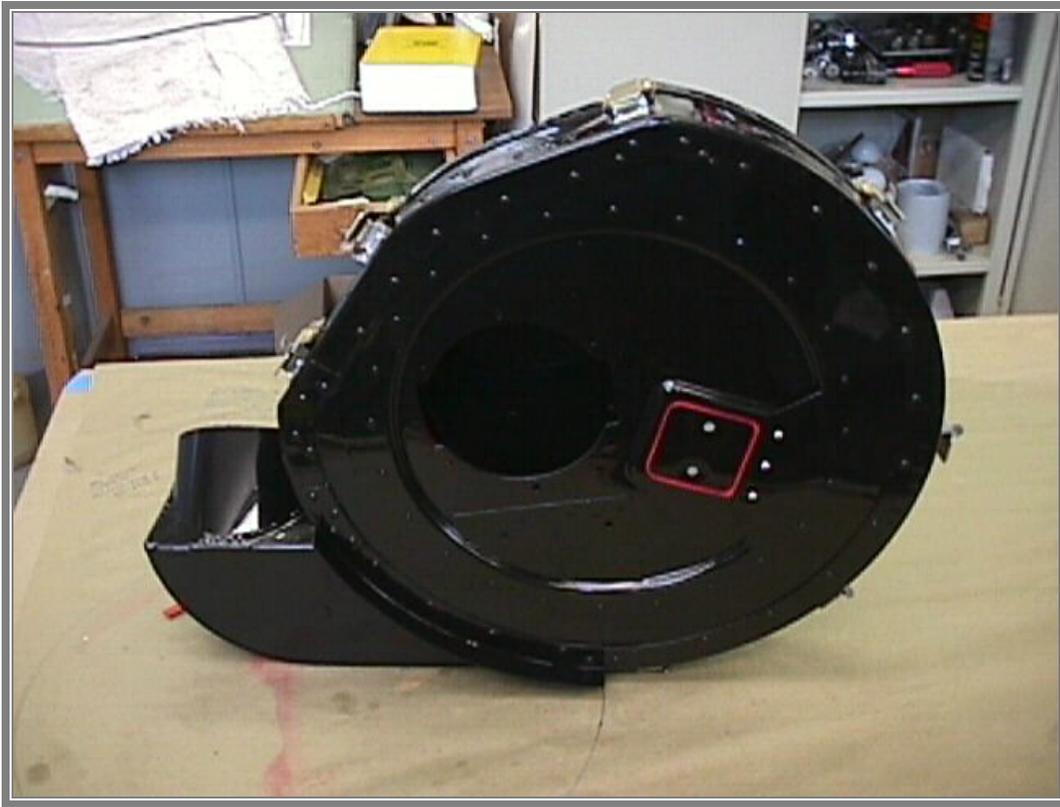
COMPLETED INDUCTION HOUSING ASSEMBLY
