COMANCHE GEAR

MAIN LANDING GEAR SIDE BRACE SUPPORT AND STUD ASSEMBLIES

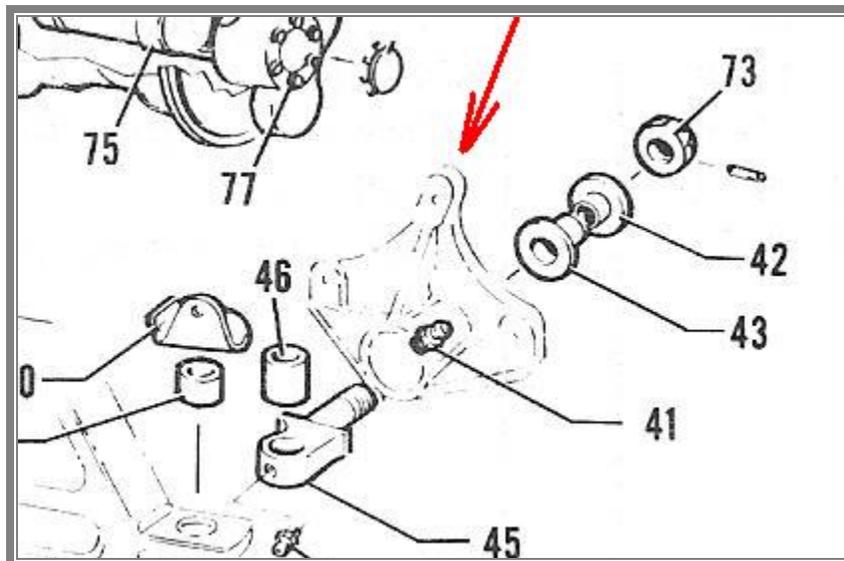
IN THIS PHOTO YOU CAN SEE THE DAMAGED BORE IN THE FORGING; THE RED MARK [ARROW] SHOWS WHERE THE BUSHING WAS “WORKING”. THIS WAS PROBABLY CAUSED BY IMPROPER REMOVAL AND INSTALLATION OF THE NEW BUSHINGS; ALIGNMENT IS CRITICAL DURING ASSEMBLY.

WHEN REPLACING THE BUSHINGS BE AWARE THAT HEATING THE ALUMINUM BEFORE REMOVAL AND INSTALLATION IS IMPORTANT, OTHERWISE IT IS POSSIBLE TO DAMAGE THE FORGING BORE, AND THE RESULT CAN BE THE NEW BUSHING MAY NOT HAVE THE REQUIRED FIT. THESE FORGINGS WERE BRUTALLY EXPENSIVE [\$448] IN 1998 WHEN PIPER DISCONTINUED THEM; BE CAREFUL, THEY ARE CURRENTLY NLA AND YOU MAY BE STUCK WITH AN UNKNOWN SALVAGE PART. ALSO IMPORTANT TO KNOW, AFTER INSTALLATION OF THE NEW **BUSHINGS** IN THE SIDE BRACE SUPPORT, THEY WILL REQUIRE REAMING TO SIZE AND FOR HOLE ALIGNMENT; THAT'S WHY PIPERS' BUSHINGS ARE UNDER-SIZE ON THE I.D. WHY **BUSHINGS** - IT IS INAPPROPRIATE TO REPLACE JUST ONE; YOU WILL NEVER HAVE ALIGNMENT OF THE INTERNAL BORES UNLESS YOU REPLACE BOTH IN ONE BRACKET, FOLLOWED BY THE REAMING OPERATION. YOU MUST REAM THEM OR THE INTERNAL BORES WILL NOT BE IN ALIGNMENT; THINK ABOUT IT! IN ADDITION I USE A HONE AFTER REAMING TO IMPART A CROSS-HATCH FINISH FOR BETTER LUBRICITY.
