# SERVICE LETTER

No. 596A

Piper Aircraft Corporation

Subject: Nose Landing Gear System Product Advancement Information.

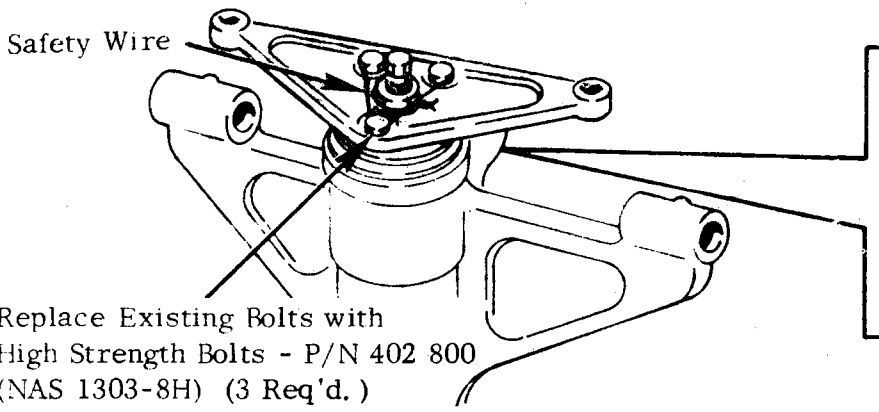
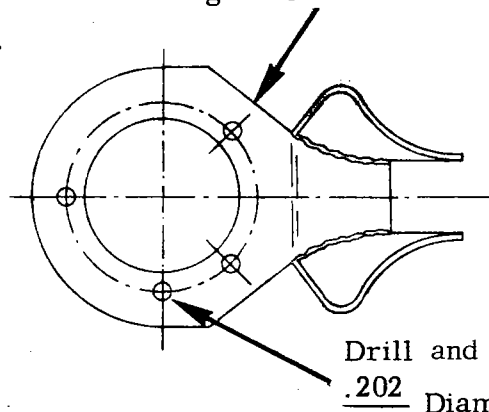
1. Nose Gear Aligner Guide Bracket Assembly - applies to all aircraft specified in Material Required No. 1, below:
  - a. Inspect existing Nose Gear Aligner Guide Bracket; if guide channel material thickness is .062", replace with new Aligner Guide Bracket Assembly, part number 21719-11. NOTE: It is recommended that the new Aligner Guide Bracket be installed using the new "High Strength" Attachment Bolts, specified below. Prior to installation, check attachment bolt hole size (in Aligner Guide Bracket) to insure .202" diameter, as shown on top portion of attached sketch. .204

Replace Existing Bolts with High Strength Bolts - P/N 402 800 (NAS 1303-8H) (3 Req'd.) Torque 30-35 in. lbs.

Drill and Ream Holes .202 / .204 Diameter
