SERVICE LETTER

No. 751

Piper Aircraft Corporation

Fin Front Spar Modification.

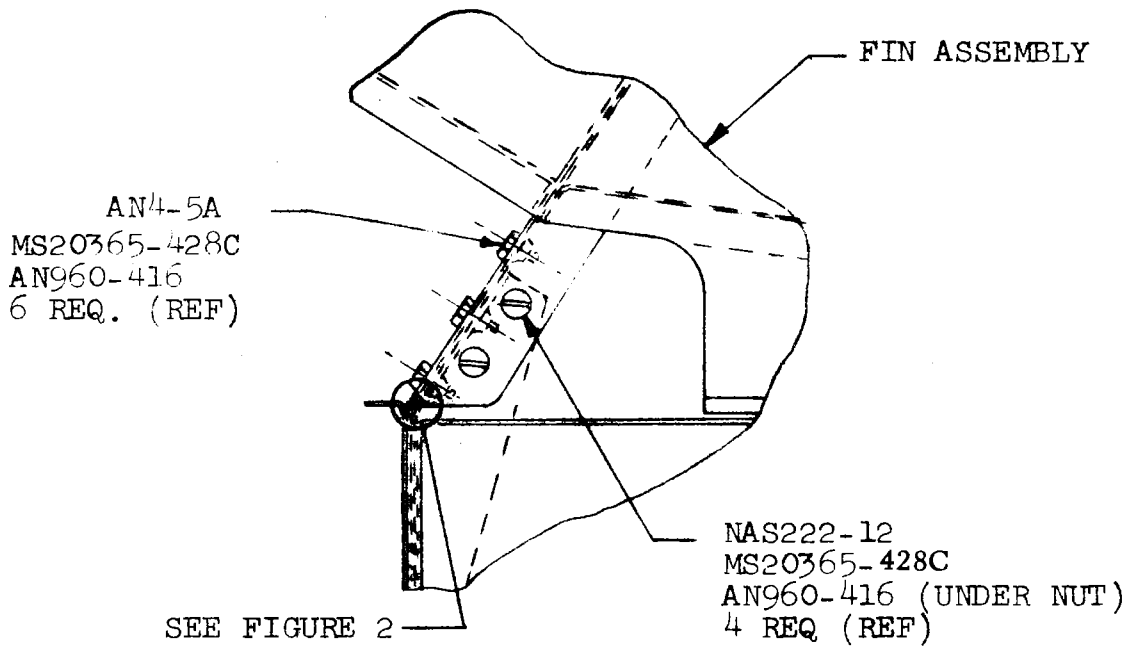
FIGURE 1

Currently, it is necessary to physically remove the fin to gain visual access to the channel relief holes, as the fin front spar extends over the relief holes by approximately 1/2 to 2/3 of the relief hole diameter.

To eliminate removal of the fin and to enable an easy visual inspection, the fin front spar may be modified in accordance with the sketch/instruction sheet contained on the reverse side of this release.
