SERVICE BULLETIN

No. 464A

Piper Aircraft Corporation

Subject: Inspection of Stabilator Torque Tube Bearing Block Attachment Fitting Rivets.

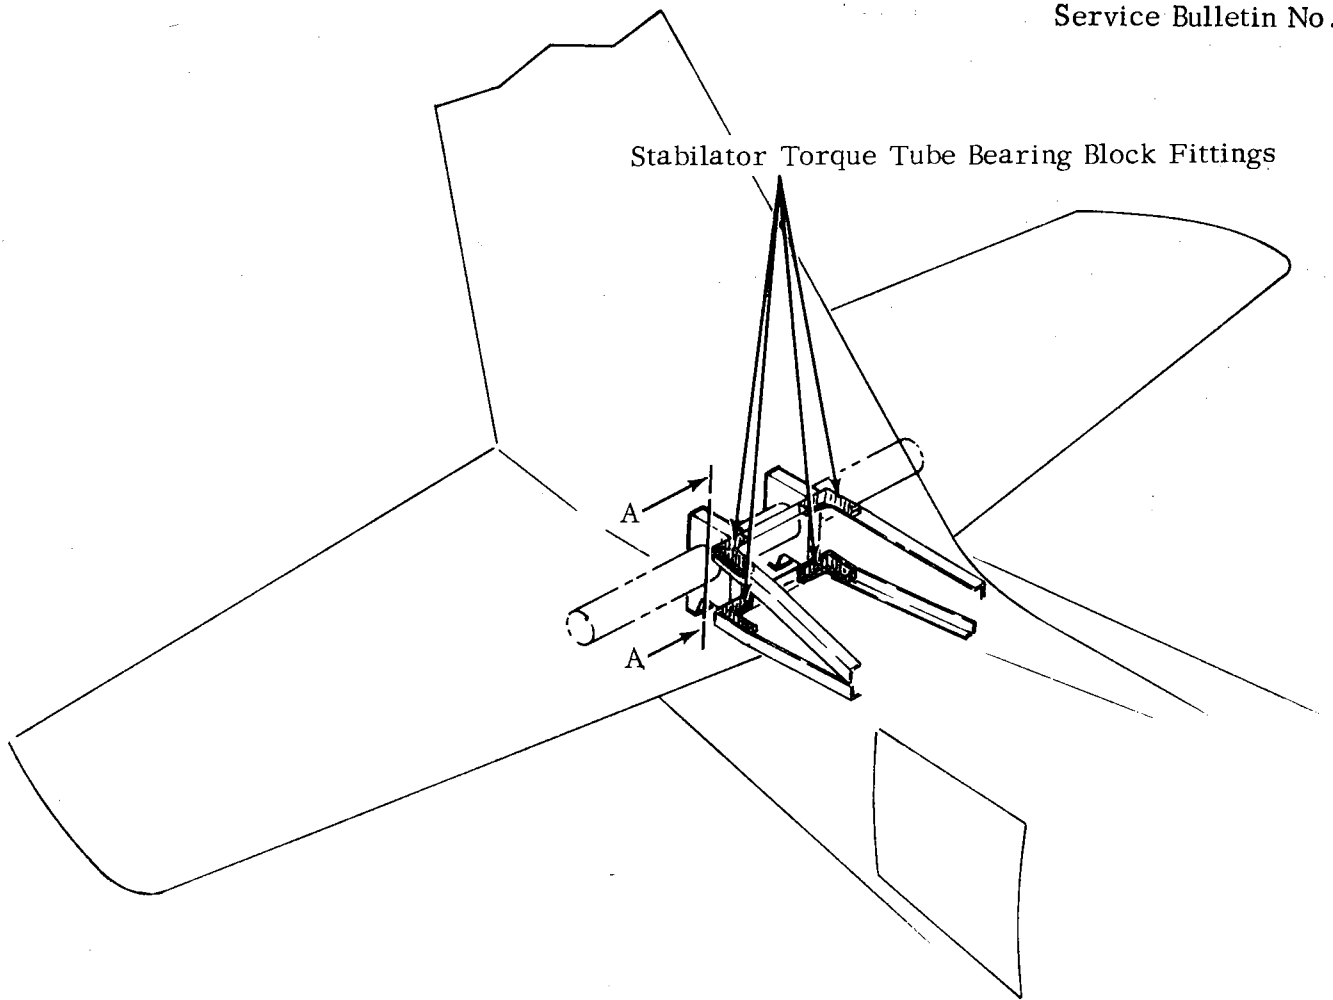
Stabilator Bearing Block Attachment Fitting Rivets (see sketch for an illustration of this condition).

A study was conducted to determine the significance of the above described condition. It was subsequently determined that the rear corner rivet in the bearing block fitting (which is most susceptible to drill penetration) is redundant to the structural integrity of the fitting assembly, and also that one additional rivet located in the bearing block could be removed without reducing the strength of the assembly below an acceptable value. However, if more than two rivets per fitting (described above) have been penetrated during the drilling operation, it will be necessary to install one (1) each per fitting Piper Kit Number 760 835, Hi Shear Rivet Replacement, and install bolts (per kit instructions) in place of the existing rivets in those bearing blocks which contain more than two rivets penetrated during drilling.

1. One (1) each PER FITTING (i.e., each kit contains sufficient material to modify one only Stabilator Torque Tube Bearing Block Fitting), Piper Kit Number 760 835, Hi Shear Rivet Replacement, if required per Instructions number 3, above.
2. Two (2) each per aircraft Cover Plate, Part Number 28216-02, if installation of Kit 760 835 is required per Instructions number 3, above.
